CONDITION SURVEY OF THE SLAVE QUARTER
BUILDING AT WALNUT VALLEY (090-
0023/44SY0262), SURRY COUNTY, VIRGINIA

Condition Survey of the Slave Quarter Building at Walnut Valley (090- 0023/44SY0262), Surry County, Virginia

WMCAR Project No. 12-26

MARCH 7, 2013

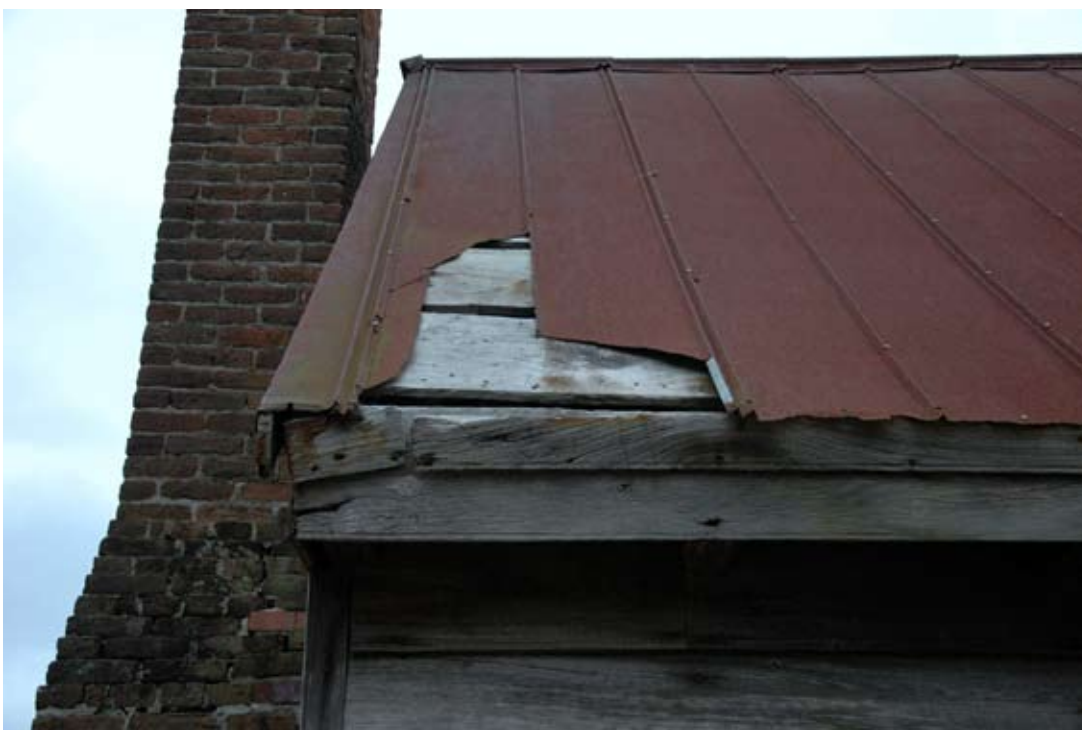
The roof is clad with galvanized sheet metal, probably dating from the early 20th century. This covering is rusted throughout, and pinholes of rust are showing through on the inside. On the front slope of the roof, sections of this covering have blown off, exposing the sheathing boards and other vulnerable elements to the weather.

Figure 5. Failed roof covering.

An in-kind replacement of the present metal roof would not portray the *post-bellum* state of this structure. However, it would protect the building and thus ensure its continued survival. Furthermore, most buildings of the sort now have later metal coverings resembling this one.

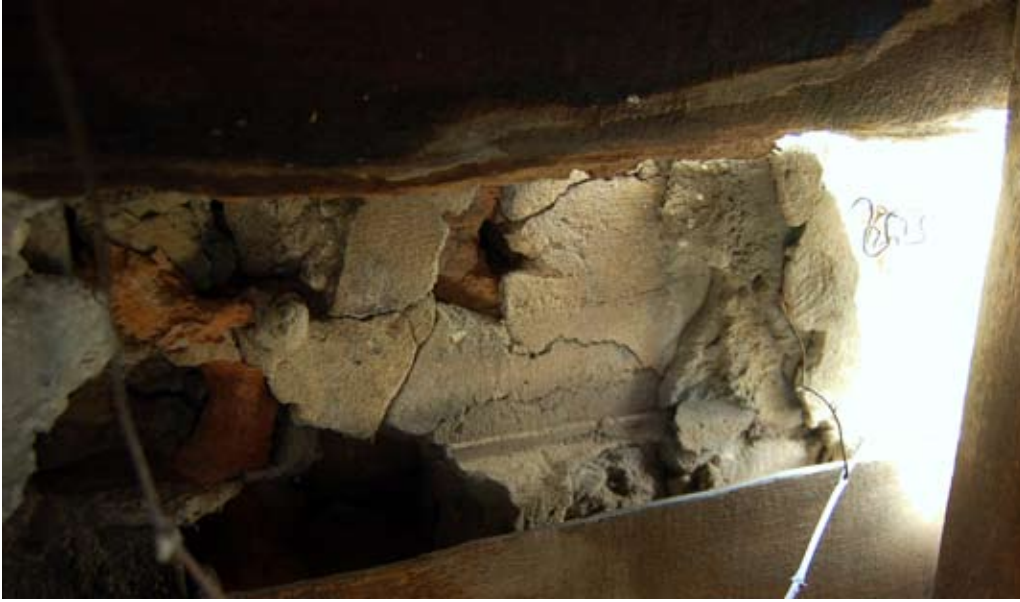
Because there was no upstairs fireplace, the upper portion of the chimney was laid directly against the original weatherboards of the gable end. As a result, the mortar on the interior face of the masonry captured the profiles of those early weatherboards (Figure 6). Each was adorned on its lower edge with a ½-inch bead; all were applied with a 6½-inch exposure. The surviving crown molding at the front eave suggests that these first weatherboards were made of poplar. The present siding is untapered, circular-sawn yellow pine, applied with wire nails. It probably dates sometime after ca. 1900. On all four elevations, some or all of this siding has failed (Figure 7).

Figure 6. Mortar bearing impression of original, beaded weatherboard.

All siding should be replaced with beaded weatherboards matching the tapered profile of the originals, as captured by the mortar on the chimney. At the ends of these boards the framing behind should be protected by Grace Ice and Water Shield. 3 x 1 1/8-inch corner boards, each with a ½-inch bead on the salient corner, should be applied at all corners, lying on the longitudinal elevations. The framing behind should be protected by Grace Ice and Water Shield. At the eaves, the weatherboards should die against the backs of the fascia boards. New 3½-inch rakes, each tapering ½-inch toward the apex of the roof, should lie over these weatherboards.

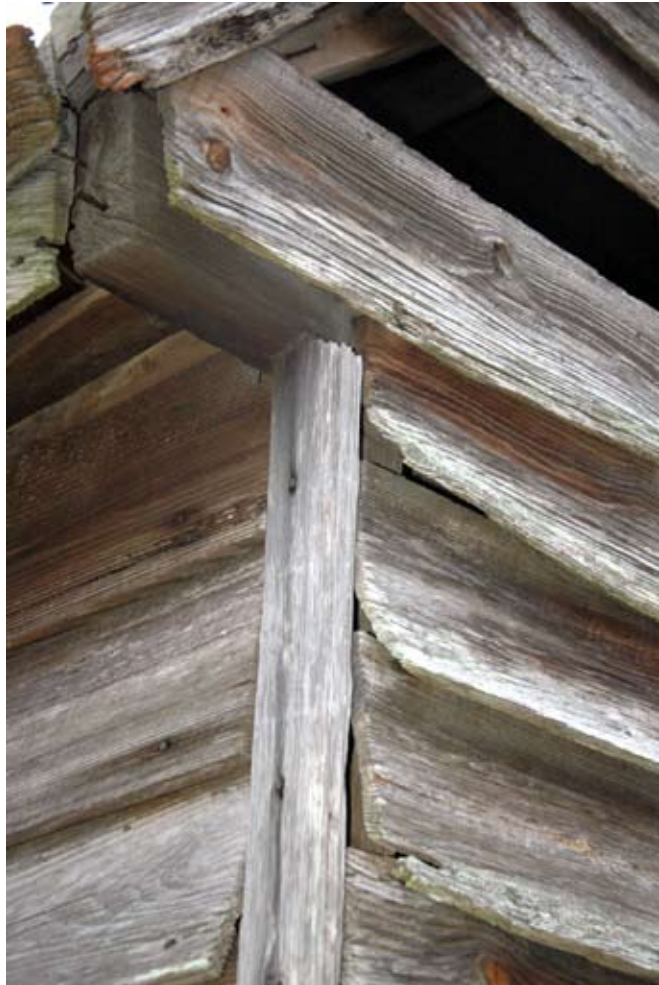
Figure 7. Late weatherboards.

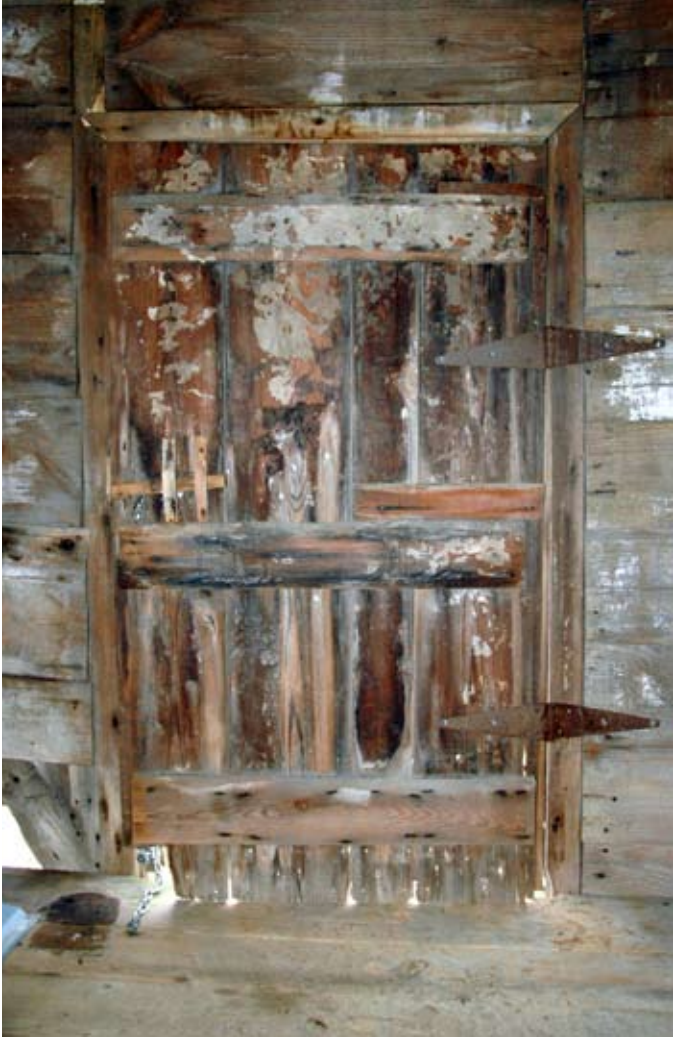
Figure 8. Interior of front door.

The “board-and-batten” front door is $\frac{3}{4}$ inch thick, having three battens on the interior face, attached with clinched cut nails. A small sliding bolt of wood secures this door in the closed position (Figures 8 and 9). The loops and keeper for this door were attached to the frame with hand-headed cut nails. The exterior bucks and head lining are pine, applied with wire nails. On the interior, the original head casing remains *in situ*, having a $\frac{1}{2}$ -inch bead on the inner edge.

The exterior head and bucks should be replaced, the new members to be 1 inch thick with a $\frac{1}{2}$ -inch full bead on the inner side of the fore edge. The interior jamb casings should be replaced as well, matching the profile of the original head

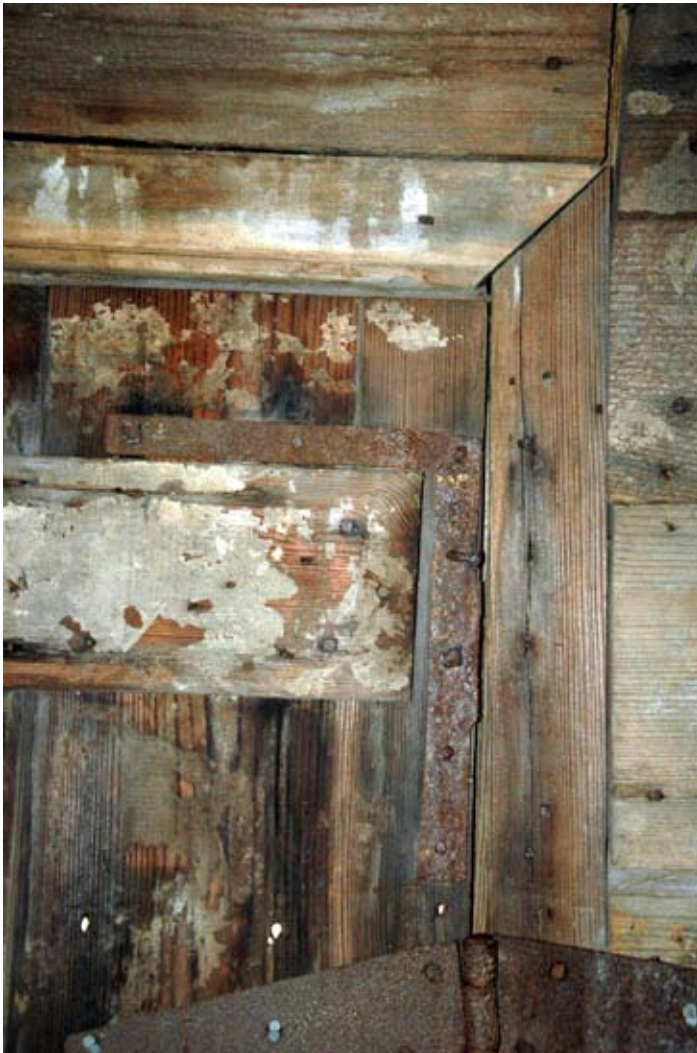
The front door currently swings on hinges dating from the twentieth century, though the door leg of the upper H-L hinge remains in place (Figure 10). After the interior door trim is restored, the upper hinge should be removed from the door, repaired, and re-applied to the door with clinched nails. The lower hinge—a mirror image of that above—should be recreated and attached to the door using existing nail holes to determine the original hinge position. The wooden keeper for the sliding bolt should be removed from the present casing and reapplied with hand-headed cut nails after the jamb casing is restored.

Figure 10. Remnant of original H-L hinge and head casing.

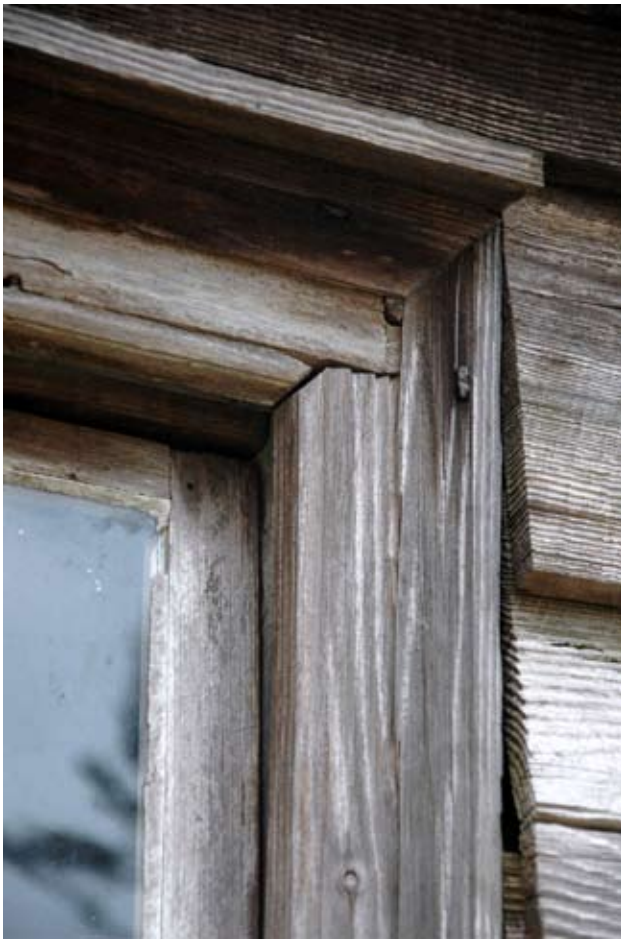
Figure 11. Original window frame.

The ground-floor window frames are cut from the solid, and they appear to be original. Some of the back bands appear to be affixed with wrought clasp nails (Figure 11). However, the sashes appear to be later nineteenth-century replacements, possibly dating to the tenant house period. In some cases, the sashes have been reversed, so that the puttied sides face the interior.

The sashes should be removed, re-puttied and, where necessary, re-glazed. They should be painted on the exterior to match other exterior trim and placed back in the windows, oriented with the putty on the exterior.

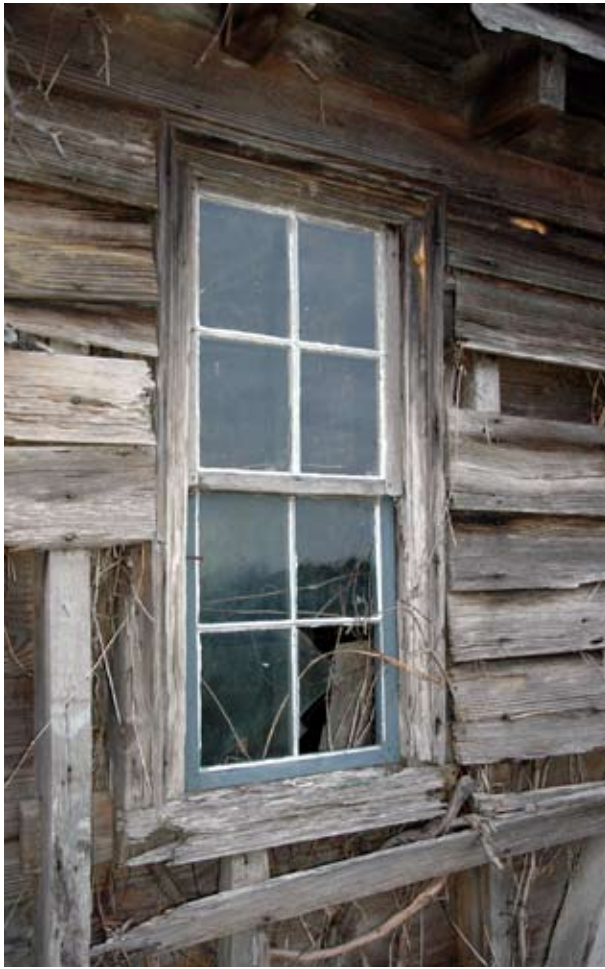
Figure 12. Rear window frame.

The sills and lower jambs of the rear window are badly deteriorated. The sill should be replaced and the lower jambs scarfed with new material matching the profiles and workmanship of the originals (Figure 12). The jambs of the front window are eroded at the lower ends and the

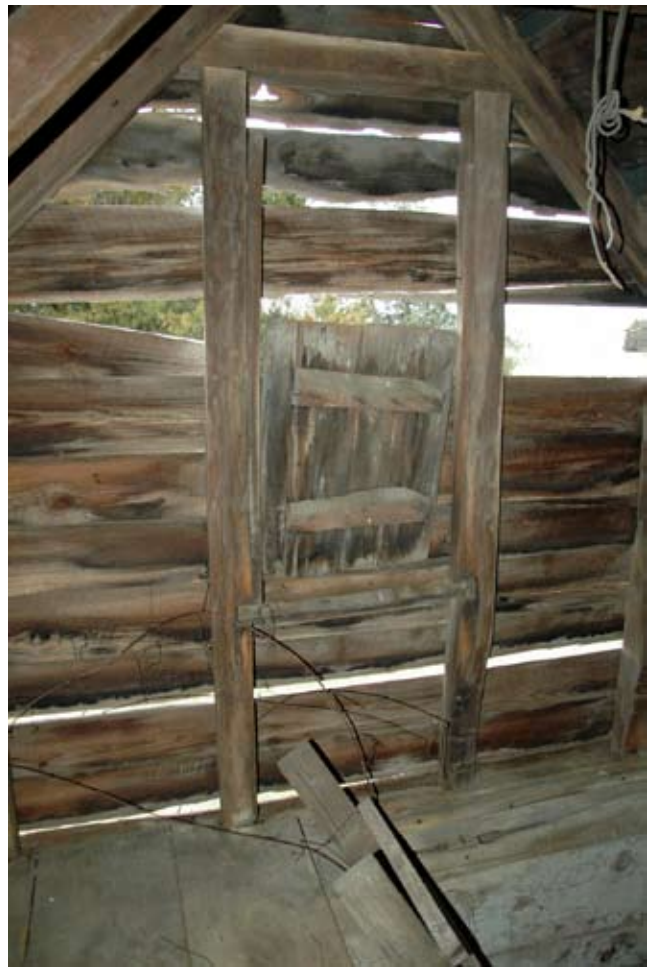
Figure 13. Gable-end window.

The shutter on the west gable window is badly deteriorated. This should be replaced in kind, the missing sill should be supplied, and the ledgers that secure the shutter should be re-attached to the studs (Figure 13).

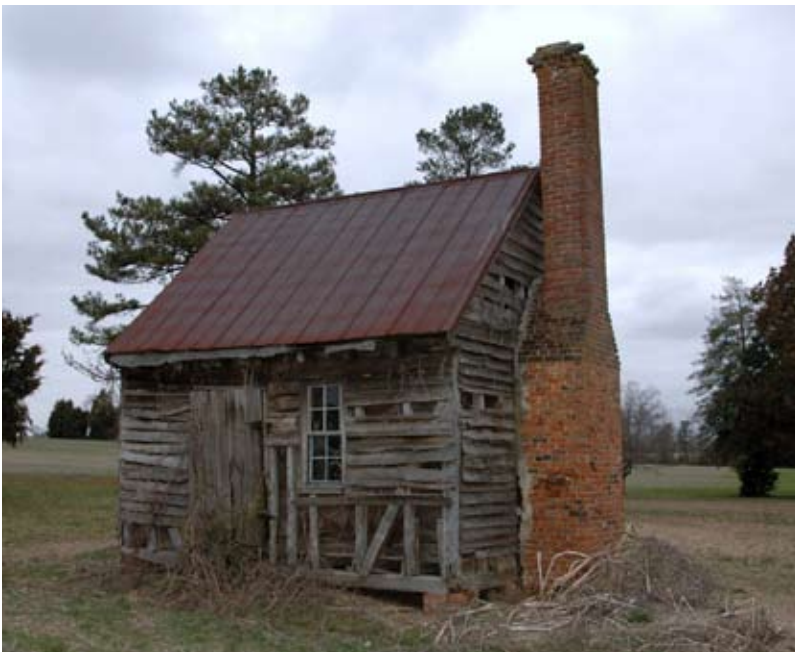
Figure 14. Chimney.

The original brick chimney, laid in 1:3 bond, remains intact, but is badly deteriorated. This masonry structure has rotated away from the gable-end wall, leaving a large gap between the masonry and the siding. At various times, this gap has been filled with mortar (Figures 14 and 15).

The fireplace and its arch should be rebuilt. Missing bricks on the top course of the chimney and the spalled bricks on the back of the chimney should all be replaced. The open mortar joints by the front weatherings should be repointed. The gap between the restored masonry and the framing of the gable end should be flashed.

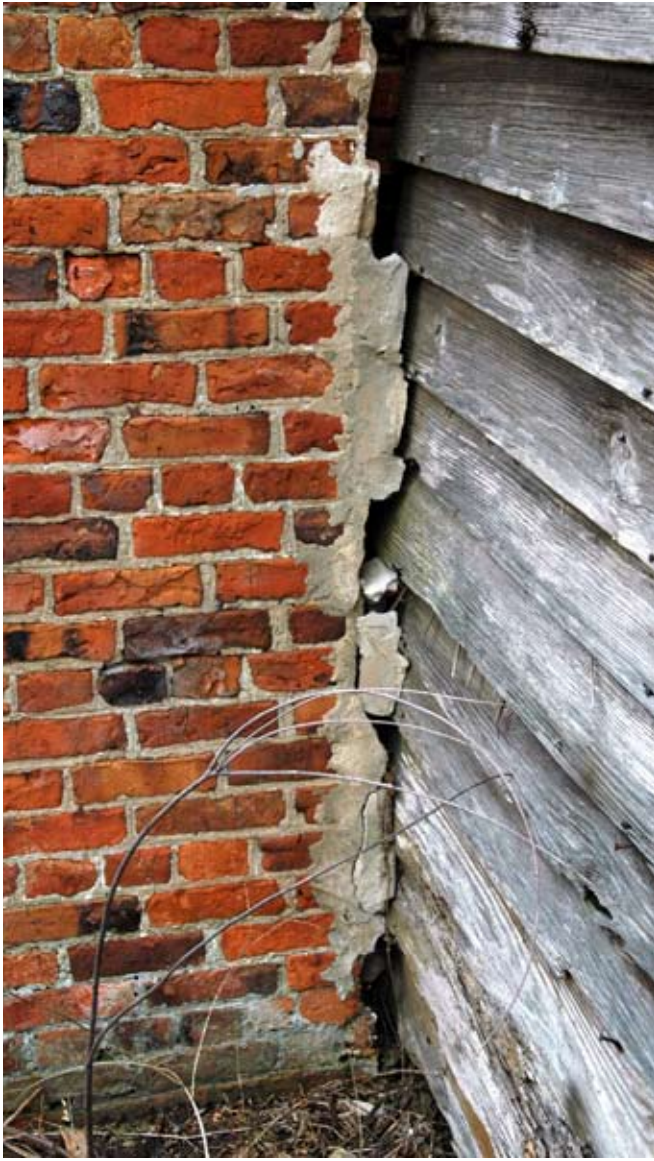
Figure 15. Chimney separated from building.

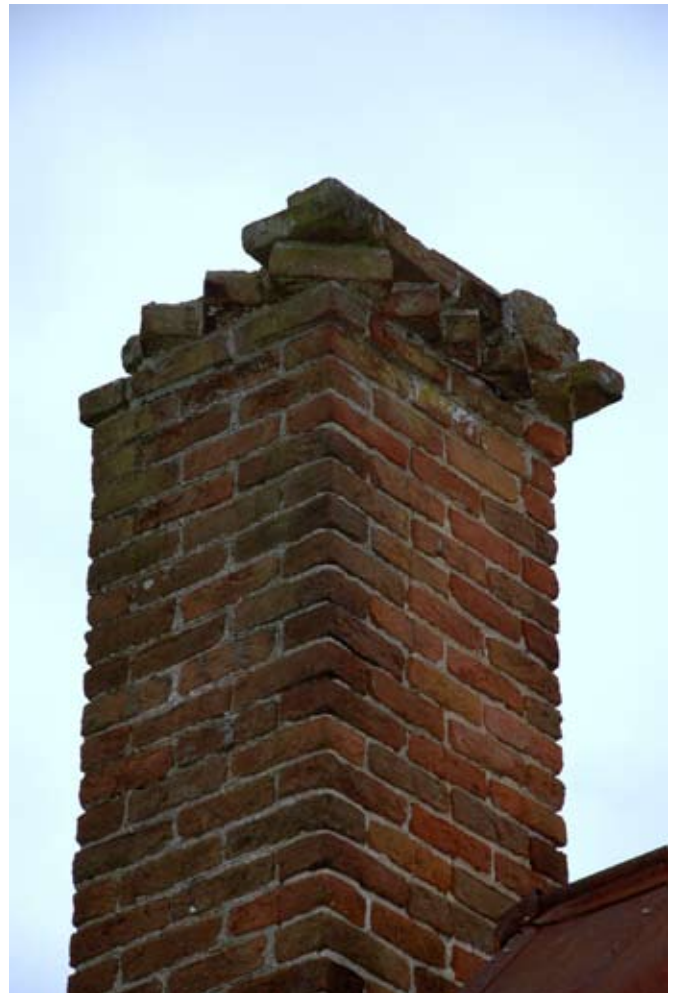
Figure 16. Chimney cap.

The top of the stack is adorned with a “mousetooth” dentil course and a flat course above it. The flat course has partly disappeared (Figure 16). On the lower section of

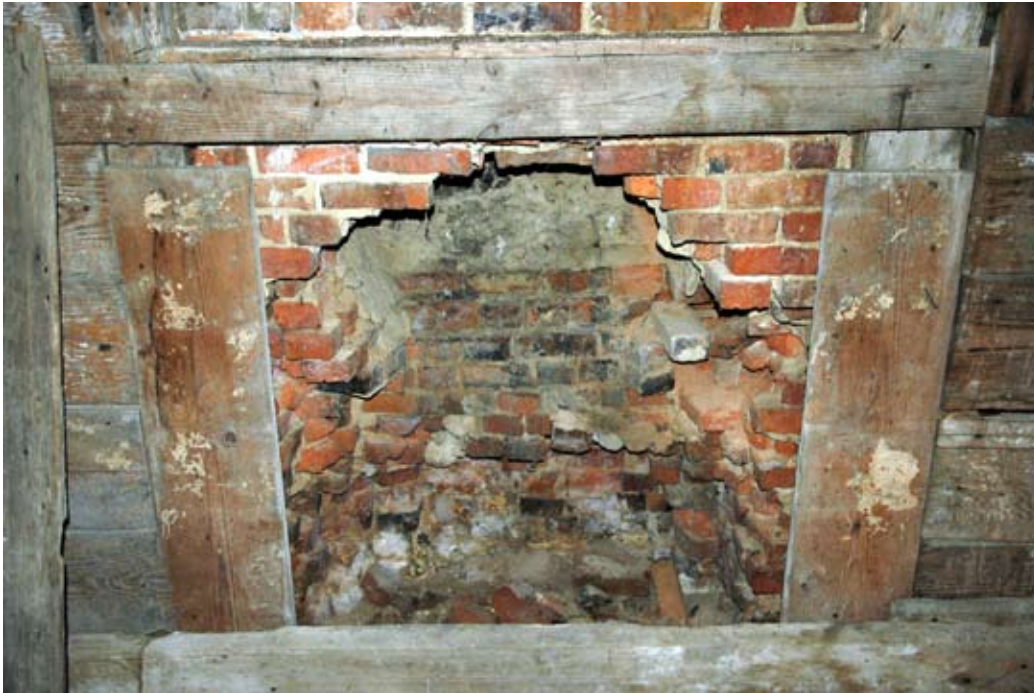
Figure 17. Collapsed fireplace jambs and arch.

the chimney, several bricks have spalled to the point of leaving a void on the exterior face of the masonry, and mortar joints have failed at the front weatherings. On the interior, the jambs of the fireplace and the arch that once bore on those jambs have all collapsed, leaving the breast of the chimney unsupported. (Figure 17).

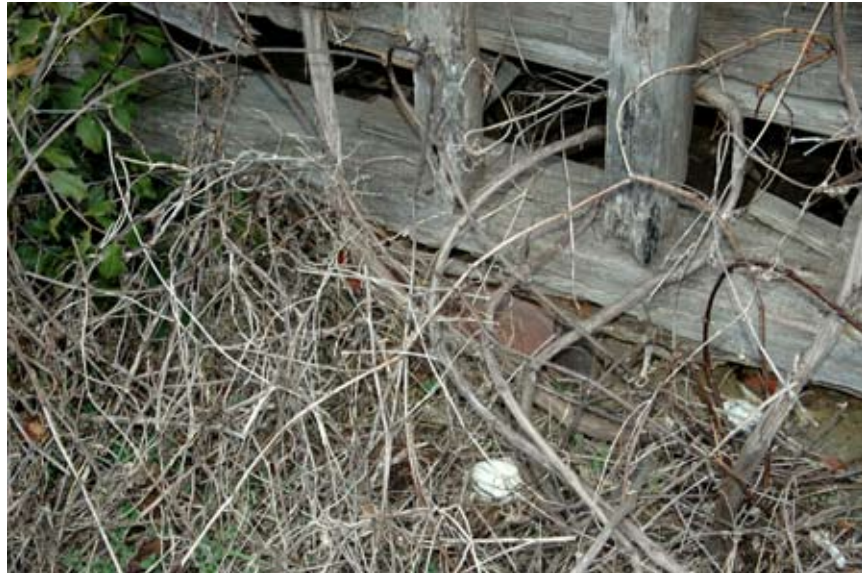
Despite failed cladding on every elevation, the framing remains intact in most locations. An important exception is the middle of the rear wall, where termites have damaged the rear sill and the adjacent joists (Figure 18). This has caused the rear wall to sag, dislodging some of the interior sheathing. A later brick pier has been laid under the sill to arrest its movement.

Figure 18. Failed framing: rear wall.

The rear sill should be replaced in kind and new joists “sistered” to the old where the latter are damaged by termites. Moreover, studs at the rear wall (and other locations) should be “sistered” where rot or insects have compromised them structurally.

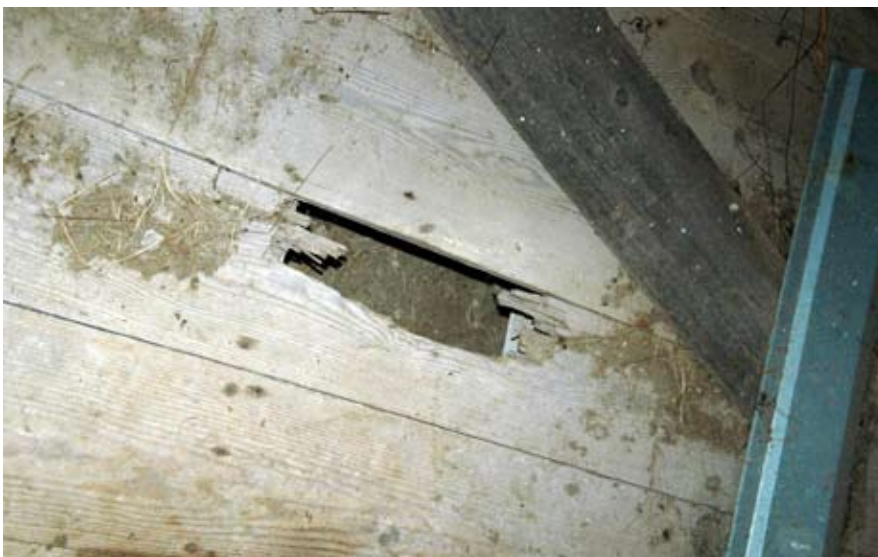
In the ground-floor room, the sixth board from the rear wall is damaged by termites, leaving a hole through the floor (Figure 19). The damaged section of the floorboard should be excised entirely, and a patch of the same species, comparable in character and grain orientation, should be let in to fill the resulting void. The new material should be face-nailed with wire finishing nails.

Figure 19. Failed flooring.
