Virginia Department of Historic Resources PIF Resource Information Sheet

General Property Information	For Staff Use Only DHR ID #: <u>042-0189</u>
Property Name(s): <u>Quietude</u>	
Property Date(s): <u>1820</u> <input checked="" type="checkbox"/> Circa <input type="checkbox"/> Pre <input type="checkbox"/> Post	Open to Public? <input type="checkbox"/> Yes <input checked="" type="checkbox"/> Limited <input type="checkbox"/> No
Property Address: <u>7351 McClellan Rd</u> City: <u>Mechanicsville</u> Zip: <u>23111</u>	
County or Ind. City: <u>Hanover</u> USGS Quad(s):

Quietude Floor Plan

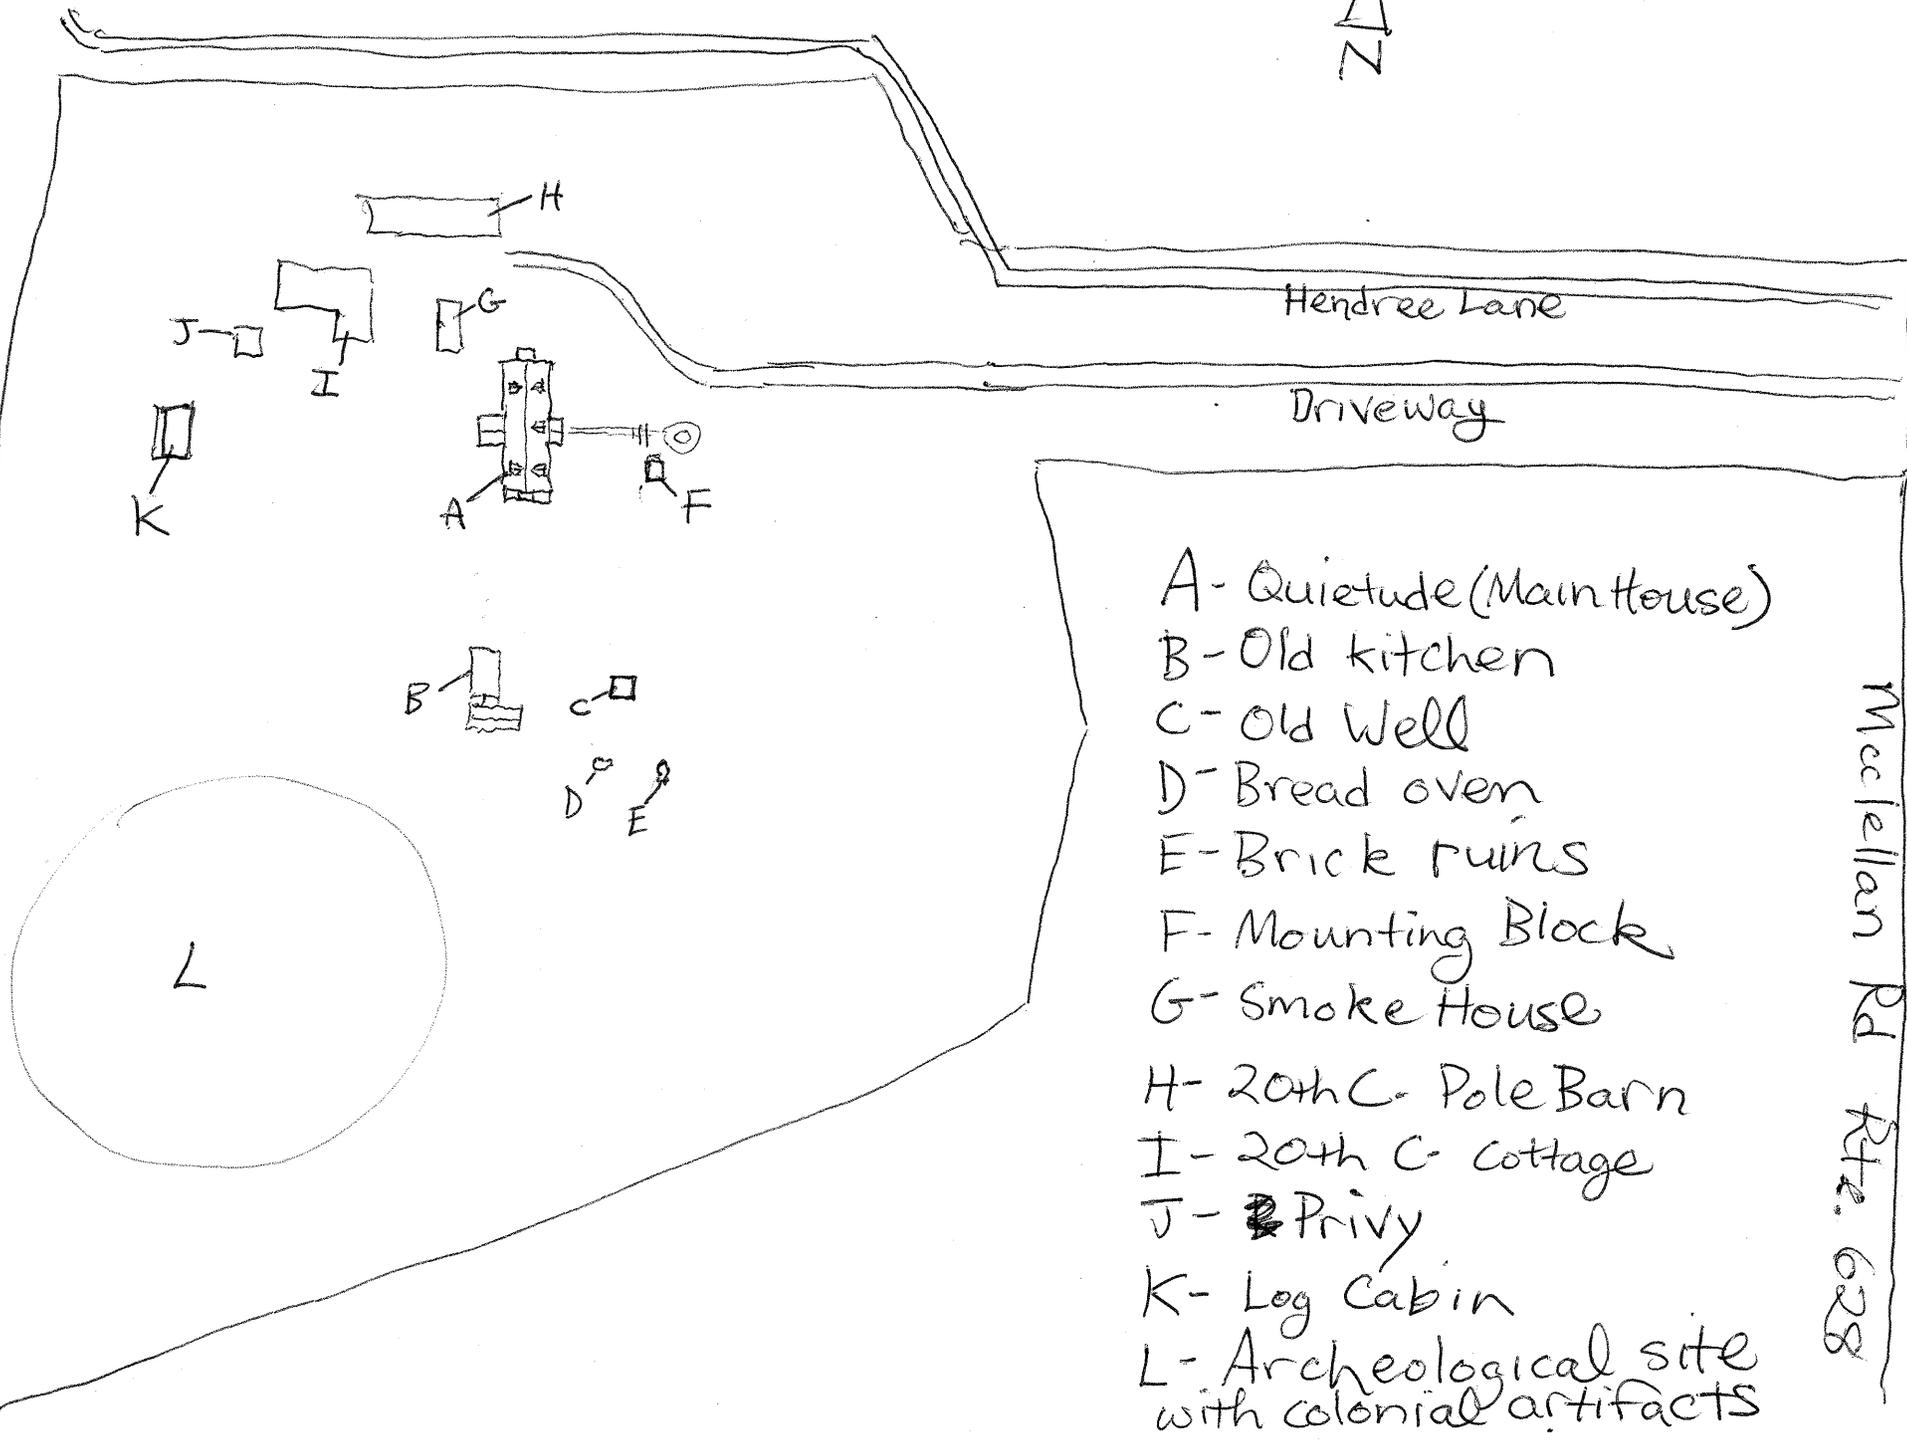
Not to scale

- A- Quietude (Main House)
- B- Old kitchen
- C- Old Well
- D- Bread oven
- E- Brick ruins
- F- Mounting Block
- G- Smoke House
- H- 20th C. Pole Barn
- I- 20th C. Cottage
- J- ~~Pr~~ Privy
- K- Log Cabin
- L- Archeological site with colonial artifacts
