Virginia Department of Historic Resources PIF Resource Information Sheet

| Property Name(s): <u>Thomasson Barn</u> | |

Thomasson Barn at Innovation Park

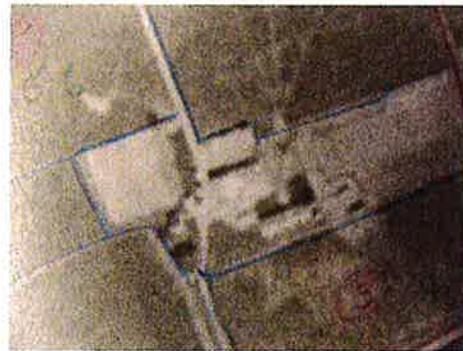
*1937 Aerial Map of Thomasson Dairy Barn
Prince William Co. Library Relic Collection*

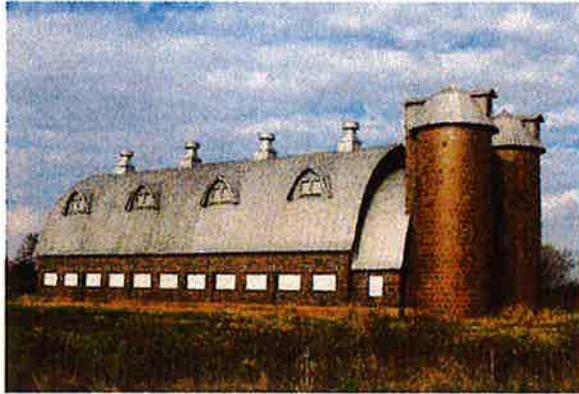
Innovation Barn Today

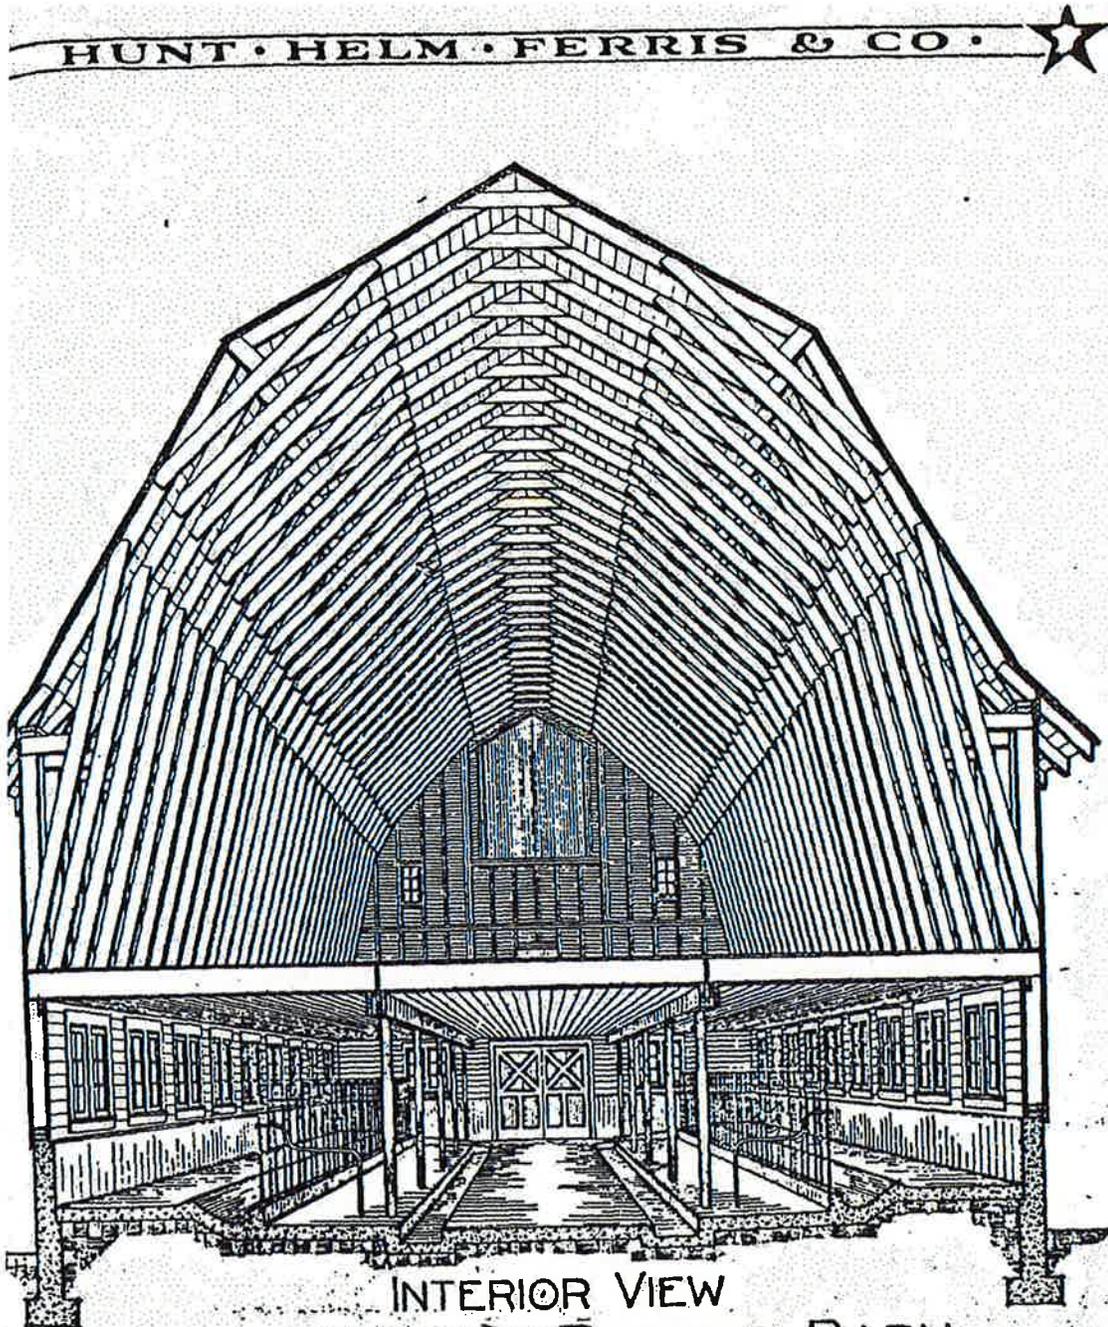
One Hundred Fifty-two

INTERIOR VIEW
STAR BRACED RAFTER BARN
PLANK FRAME CONSTRUCTION

The roof framing is made up of three part composite ribs of 2" x lumber segments. The ribs are spaced at 2'-6" o.c. and are framed to create a clear span circular arch of intersecting segments approx. 38' in diameter. There are four deep transverses stiffening trusses built within the roof system. They are spaced at 10, o.c. from the east and north end walls of the main barn block respectively and are marked with 1" x 6" sheathing throughout. The circular walls of the silos are built entirely of glazed terra cotta masonry units normally 12"x12".

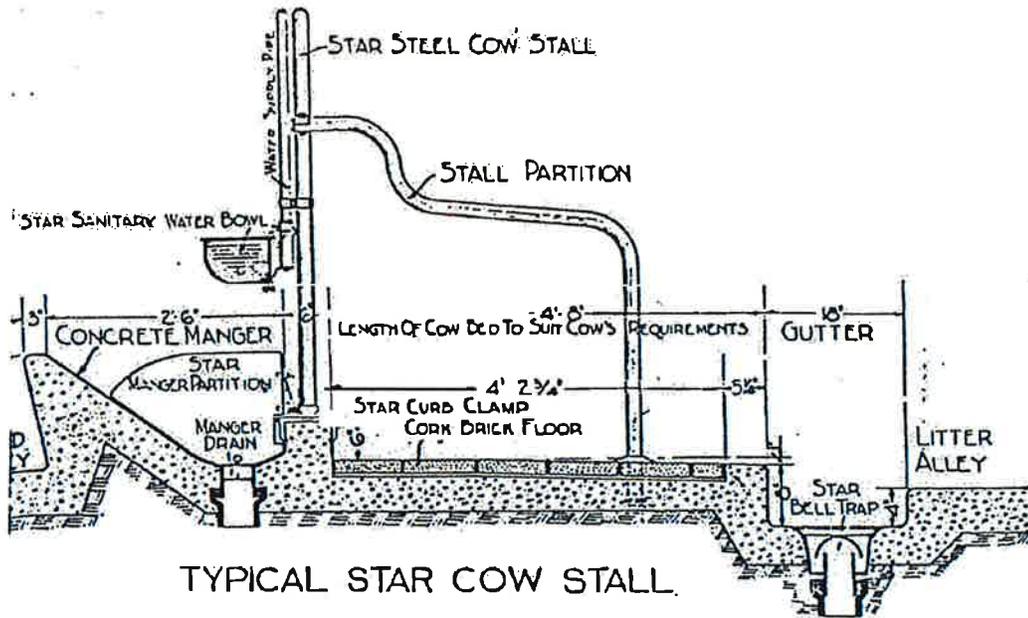
TYPICAL STAR COW STALL.

Figure 2a: Example of stall or stanchion. From Hunt, Helm, Ferris and Company, *The Starr Line*, Catalog 75. (Albany, New York and Harvard, Illinois, p. 139.
