National Register of Historic Places Registration Form

Historic name: Lynnhaven House (Additional Documentation and Boundary Decrease)

Other names/site number: Wishart-Boush House; James Wishart House; DHR #134-0037

Street & number: 4405 Wishart Road

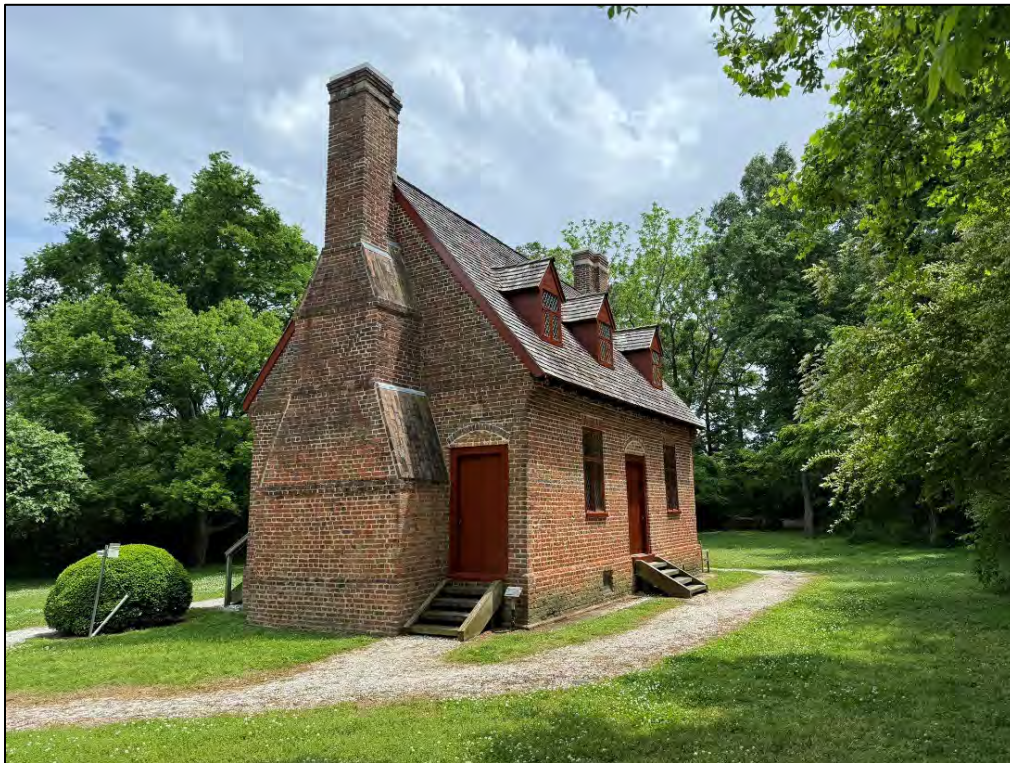
Lynnhaven House, NW oblique, May 2024. Cemetery is located in the woods at the rear of this photo.

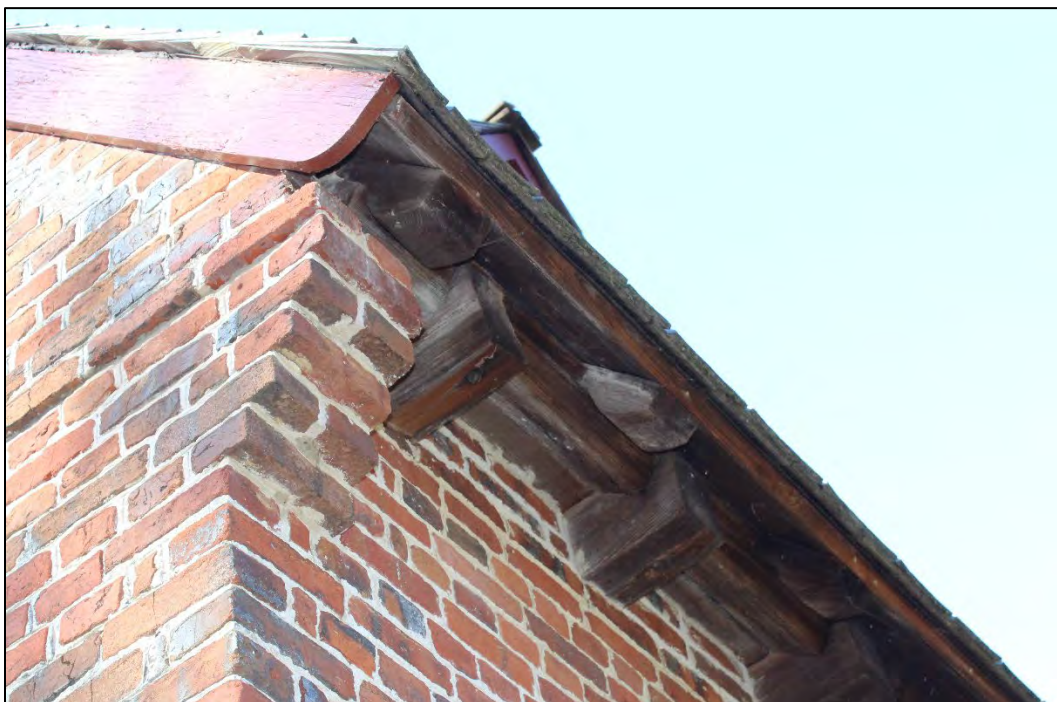
Cornice detail, SE corner, December 2023

The eaves also expose the tilted false plate roof construction. Unlike many refined Georgian houses, the cornice at the Lynnhaven House is open, or unboxed, exposing the curved ends of the rafters and the tilted false plate that they are notched over. The false plate is capped at the ends by large brick corbels that extend seamlessly from the brick walls.

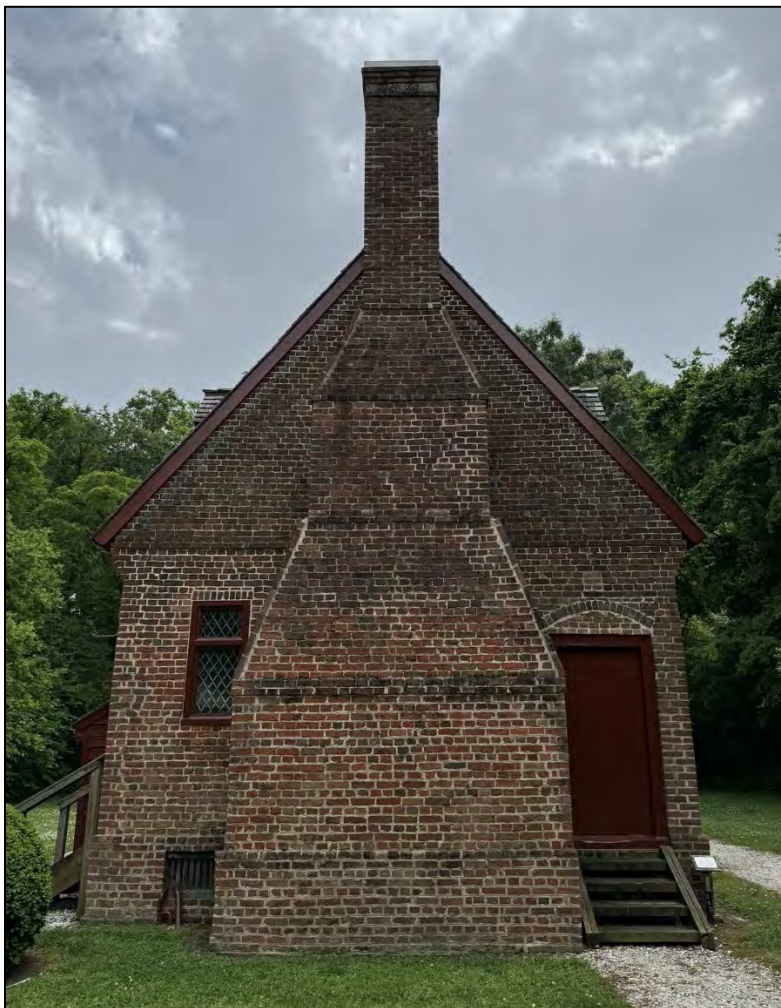
North side elevation, May 2024. Original window opening on the first story and original cellar window opening to the left of the chimney. Original doorway to the right of the chimney. Note glazed headers following the rake of the roof.

To the right (west) of the chimney is a door that appears to be an original opening. Physical evidence in the masonry, and in the lintel visible from the interior, suggest that this opening is original to the house, though this conclusion has been much debated over the years. The opening is capped with a segmental brick arch and this, along with the door frame, sill, and leaf which matches the front door, dates to the APVA restoration. The 1934 HABS drawings of this side of the house show a jack arch with alternating glazed headers above this door. Like the front door, this one is accessed via a simple ladder-style set of wooden steps.

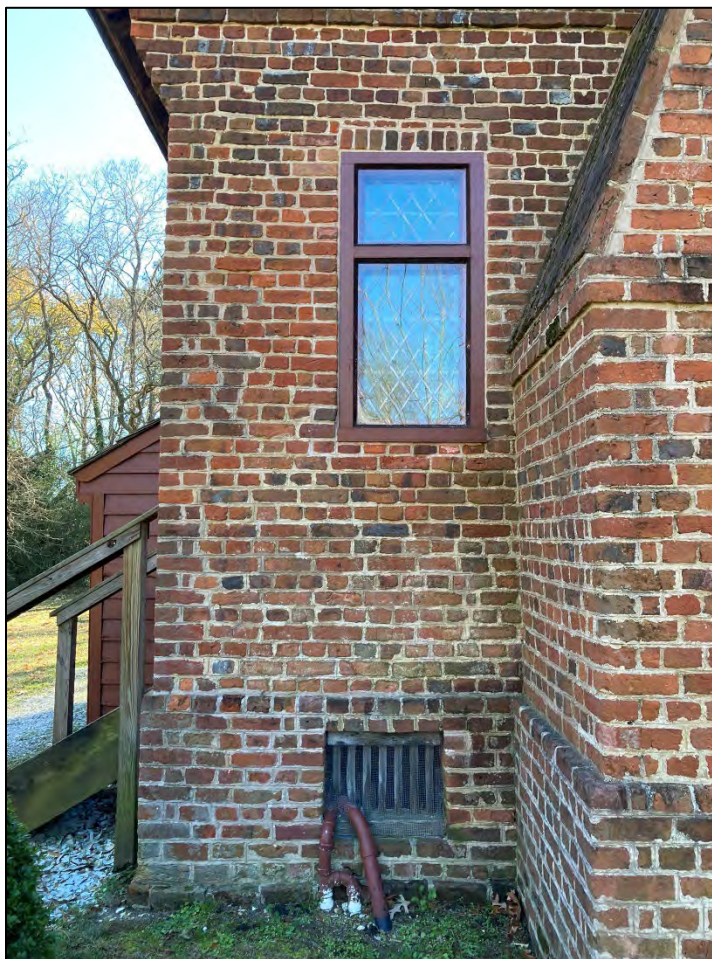
North side elevation, original sized window openings

with alternating glazed headers. There is also an original window opening in the cellar to the left of the chimney. Like the one found on the front elevation, this small window opening has a wooden sill and header and seven diamond-set vertical wooden bars. The surrounding masonry suggests that this is an original opening.

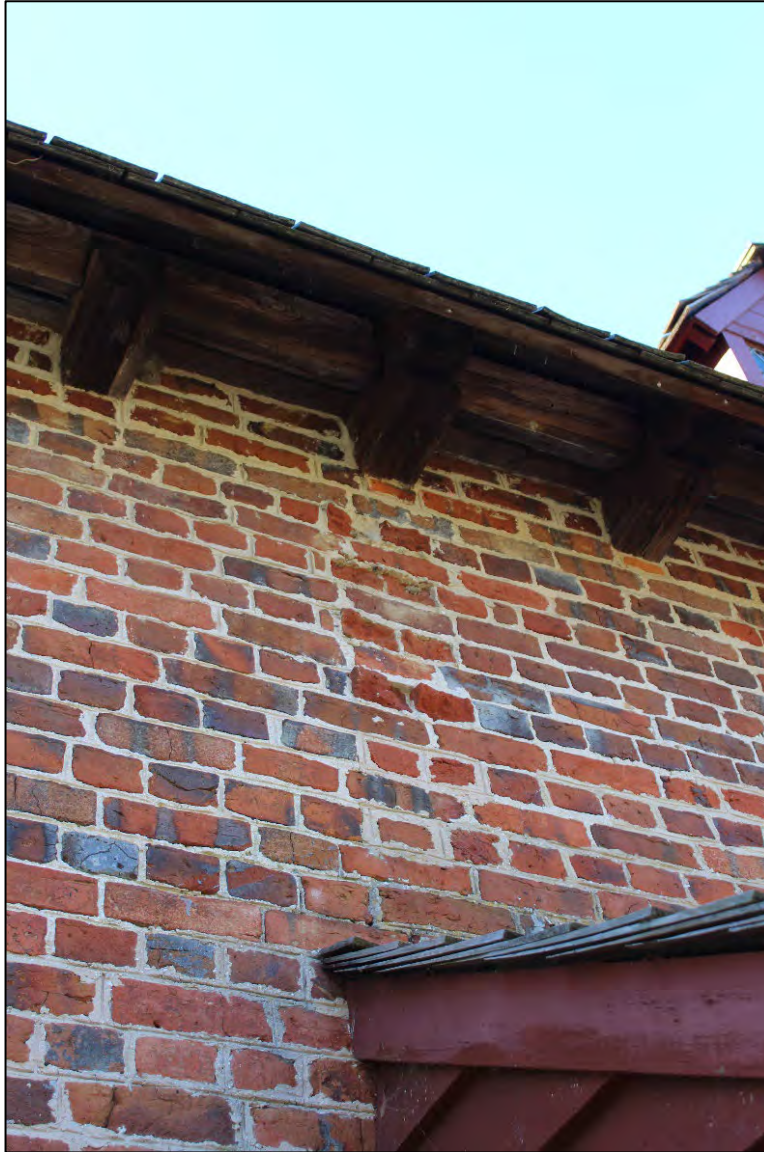
Evidence of missing rear wing. Note broken bricks in the middle of the photo. December 2023.

evident here, though reconstruction during the APVA restoration has obscured it somewhat. HABS documented original surviving plaster on this portion of the wall between these vertical markers in the 1930s (see photo below), though only small traces remain today. Willie Graham noted that the mortar joints on the rear wall of the house are different on the northern half and the southern half. On the northern half, where the brickwork would have been covered with plaster as an interior wall, original surviving mortar joints show evidence of a simple, freehand, weathered joint, while on the southern half of the wall, which has always been exposed, surviving original mortar joints are struck (grapevine). Graham also documented a large hand-forged, wrought-iron spike in-situ in the attic above the collar beams that he believes marks where the roof of the one-story wing tied in with the roof of the main block. It is unknown when this original wing was destroyed. In the mid-20th century, another rear wing was added and appears in photographs, though it is unclear if it occupied the same footprint as the earlier wing. This later wing was removed shortly after APVA acquired the property. Archaeology has been done in the area to try to determine the original size of the wing, but it has so far been thwarted by heavy disturbance resulting from the APVA restoration and earlier use of the property.

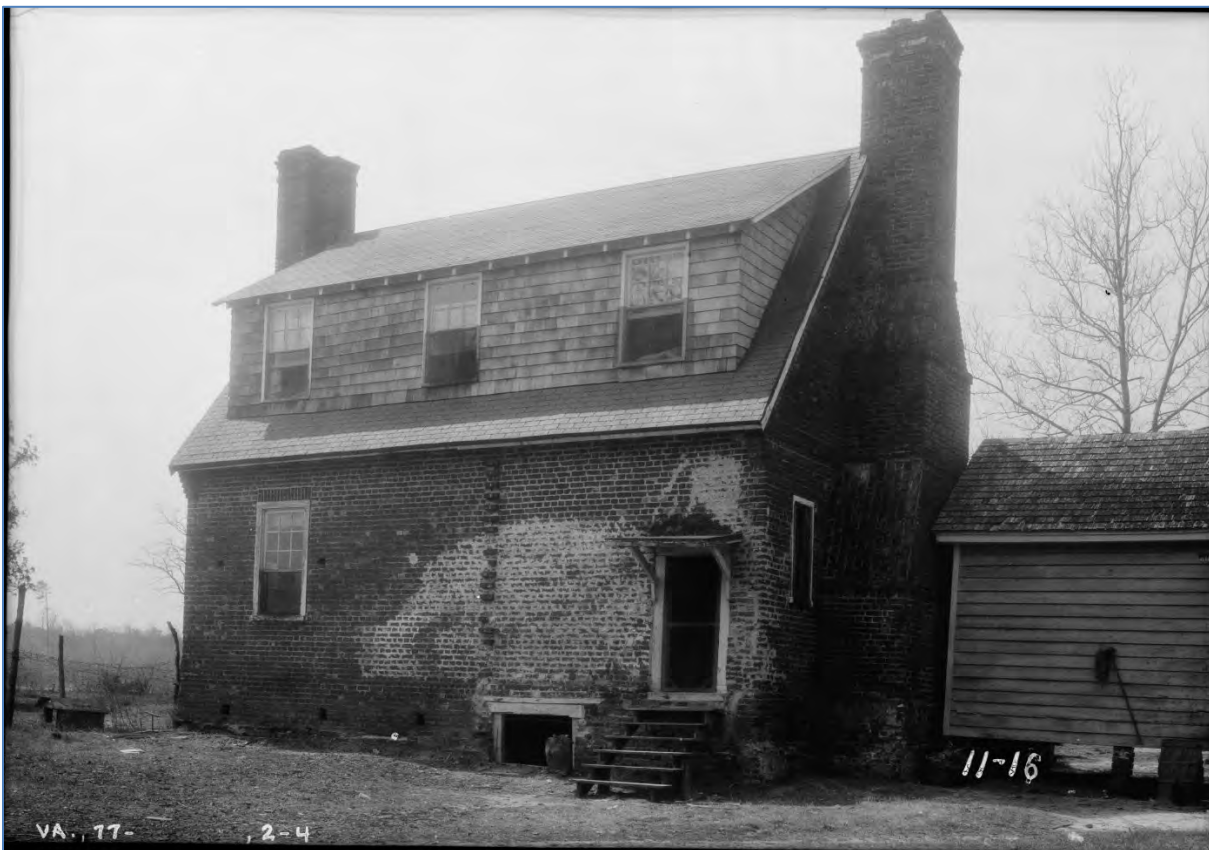
Rear elevation of Lynnhaven House, ca. 1936, showing the same brick racking illustrated by the photo above, along with surviving plaster on the rear wall. Image courtesy of HABS/Library of Congress.

The door opening that would have connected this original wing to the main house (the doorway shown in the image above and below) is now an exterior door located close to the north corner of the house. The masonry around this opening was extensively reworked during the APVA restoration, but the door frame appears to date to the early 19th century. The board and batten door leaf was designed by APVA to match the other exterior doors that they installed in the 1970s. The opening is now capped by a segmental brick arch that was constructed by APVA; the HABS drawings show a simple wood lintel over the door. Today, the door is accessed by a simple set of wooden ladder-style stairs, matching those found on the front and side of the house.

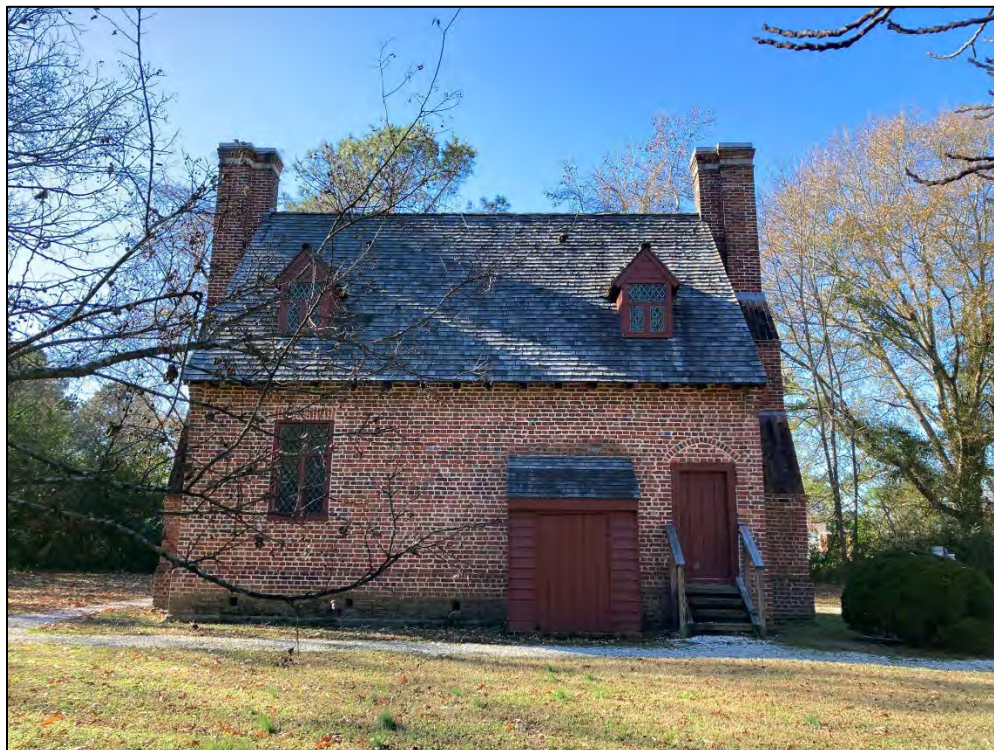
Rear elevation, December 2023.

Just to the left (south) of the first story door, is the shed-roofed frame bulkhead that shelters the original cellar door. The frame enclosure has weatherboard siding and a wood shingled shed roof and a wide board and batten door and is entirely modern, though it was intended to look older. Its construction by APVA was for the purely utilitarian purpose of providing shelter and protection to the cellar door; they knew that the enclosure did not have any historical precedent. The cellar doorway below is an original opening, though the surrounding brickwork was reworked by APVA. It is unclear at this time how access to the cellar worked originally. It would have been beneath the original wing, so perhaps an interior stair from the rear room led down to the cellar.

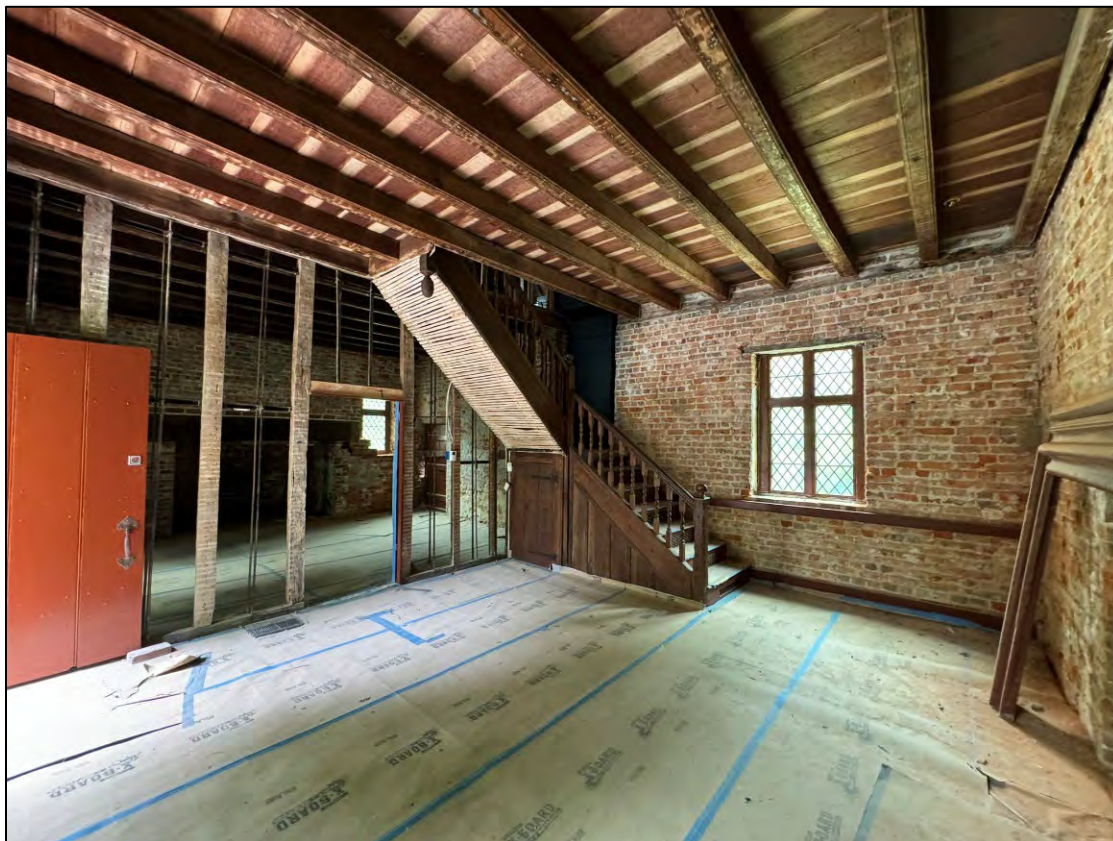
Hall. Front entrance is the open door leaf seen on the left. May 2024.

The front door opens into the hall, the larger of the two first floor rooms. The hall has wide, random width floorboards (covered; replaced by APVA) and currently has exposed brick on the south, east, and west walls and a wooden stud wall partitioning it from the parlor/dining room. There is a simple beaded baseboard on the east and west walls of the room and part of the south wall; this dates to the APVA restoration and architectural historians have found no evidence for a baseboard before ca. 1820. There is also a simple chair rail with a bead on both the top and bottom edges on the east and west walls and part of the south wall. Like the baseboards, it dates to the APVA restoration and there is no evidence for a chair rail prior to 1820. At the time of the 2018 HSR, there was a fragment of 19th century chair rail to the left of the fireplace that Graham thought could have possibly been the only surviving evidence of an early 19th century renovation of the house, though it was unclear where in the house it had been located prior to the APVA restoration. That piece of chair rail is no longer in place on the wall, but it is currently stored inside the hall firebox with other trim pieces and it is labeled. There is currently no door or window trim around any of the openings; it is believed that most of the door and window trim that was removed in the last several years dated to the 1970s APVA restoration.

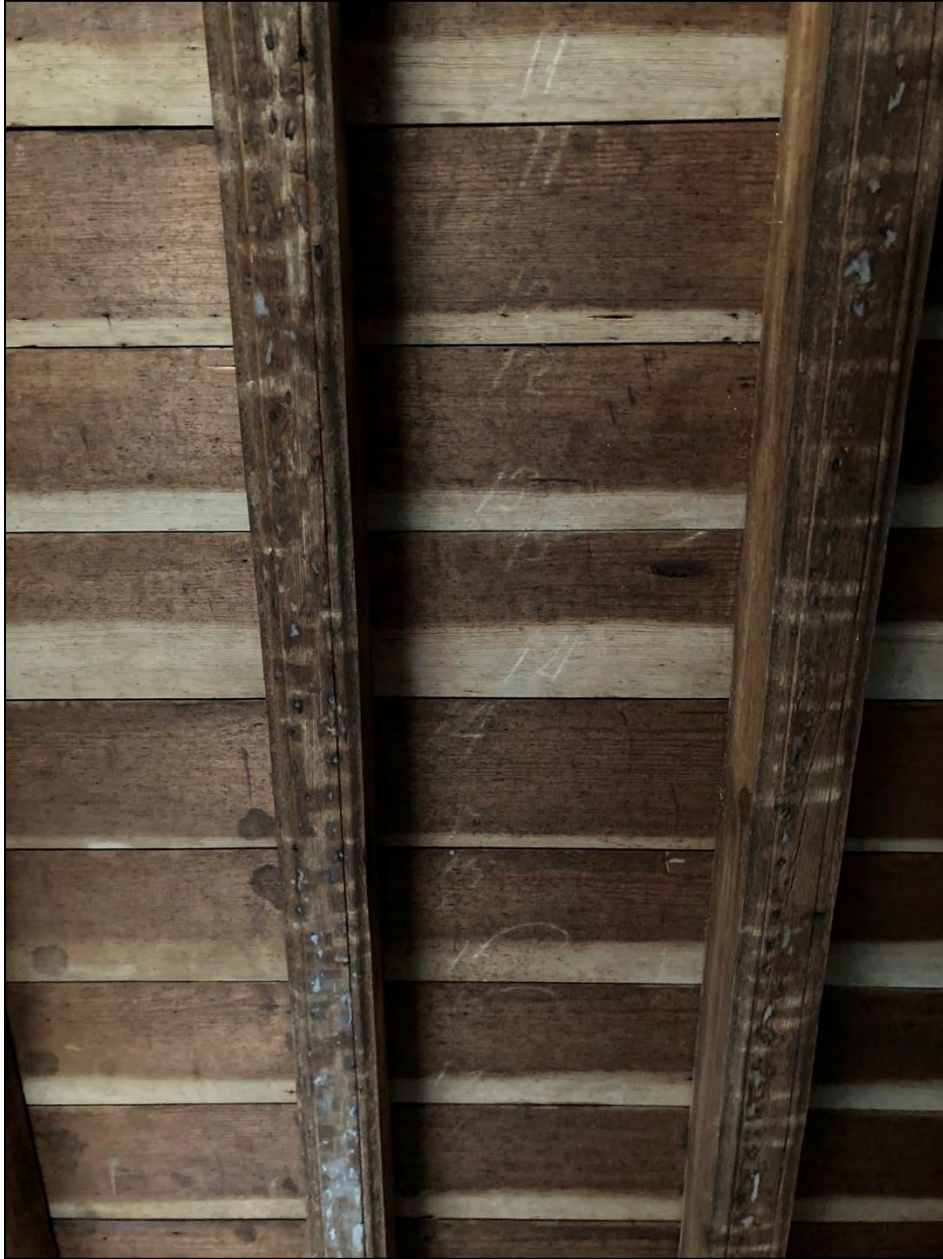
Hall, ceiling detail, exposed joists and numbered floorboards. December 2023.

Regardless, the most important and character-defining elements of the hall do remain in remarkably original condition—the ceiling, the stair, and the fireplace. An 18th century mantel, believed to be the one originally located in the parlor/dining room, is also currently leaning up against the fireplace in the hall. The ceiling of the hall is characterized by exposed framing that was meant to be seen. Hand-planed joists span the room and are molded on their bottom corners with ogee detailing that extends the full depth of the room. The bottom of the floorboards above, which were meant to be exposed, are also hand-planed and are not gauged or undercut, meaning the carpenter hand finished each board to fit exactly before setting it in place. In doing so, he numbered the bottoms of the boards with chalk with Arabic numerals (and not the more common Roman numerals) so that matching edges had the same number. These chalk marks are still visible in one location 300 years later. There is also the faint ghost of an inscribed date – “August th5 1754” (or 1734?) – on the side of one of the joists near the stair. The significance of this date is unknown.

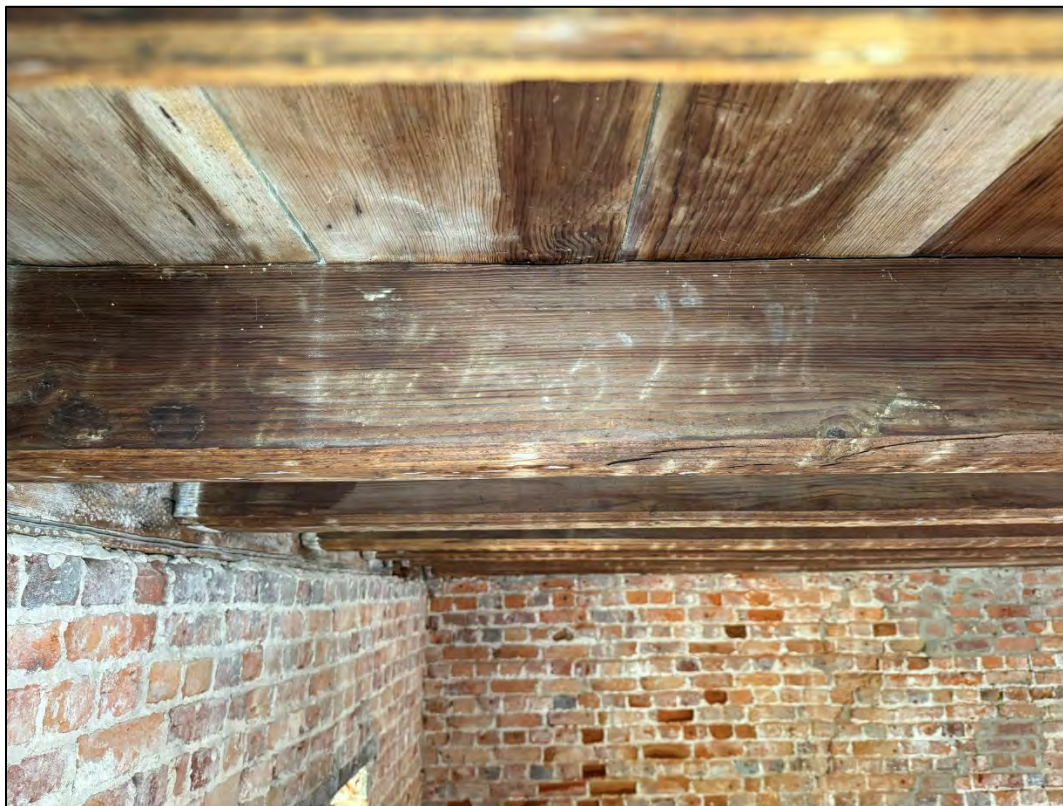
Hall, ceiling detail, “August th5 1754” [or 1734?].

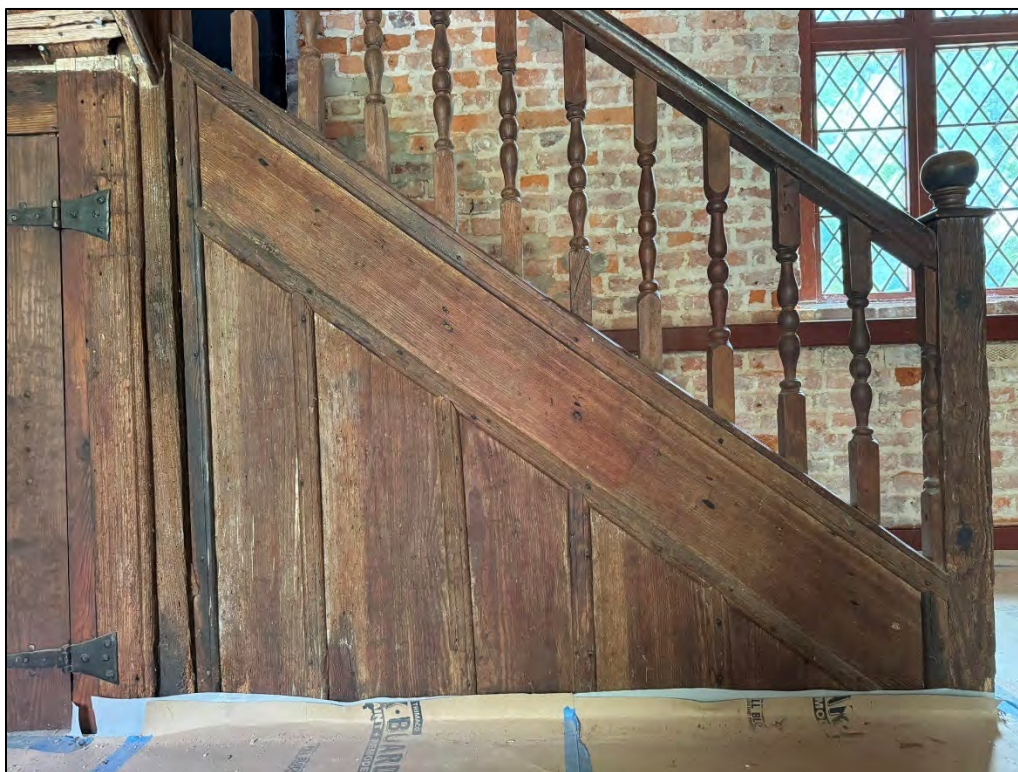
Hall, stair, May 2024.

The stair is the other character-defining element of the hall. The closed-string stair has turned balusters and square newels. The newels have applied, molded caps (all original except for the one on the bottom newel) and finials that were added by APVA (the 1934 HABS drawings note that there was evidence for circular finials but that they were not present at the time). The balusters are a rare example of early symmetrical turned balusters in Virginia, and may be evidence of the overlap between the building trades and furniture artisans, as the design bears a close resemblance to a leg on an early 18th century table from eastern Virginia in the collection of the Museum of Early Southern Decorative Arts (Narvaez and Stoll, 67). The balusters support a relatively simple but refined molded handrail. APVA added an oblong drop pendent from the bottom of the uppermost newel; the design is conjectural, but Angus Murdock asserts that APVA found evidence that an original drop pendant in the same location had been sawn off prior to their acquisition of the house (Murdock, Video interview). Stair treads are molded on their edges, though this nosing has been cut off and replicated on most of them (the original profile was documented by HABS and original molding may survive on the uppermost tread). The wall area below the stringer is paneled with original vertical boards with ovolo-molded battens at the seams. The pegged construction that connects these panels with the stair components is visible from within the closet beneath the stair. That closet also reveals a molded ceiling joist that matches those found in the hall reused as a stringer supporting the lower run of the stairs. One can conjecture that this remnant is from the hole cut in the ceiling to accommodate the stair. The floorboards inside the closet are the only original flooring remaining on the first floor of the

house. The board-and-batten door to the closet, and the strap hinges it hangs on, date to the APVA restoration. One unusual aspect of the craftsmanship of the stair is that all of the components are simply butted and toenailed together, rather than being connected with mortise-and-tenon or dovetailed joinery. Nails are mostly T-headed, though a few are rose headed wrought nails. This simplified method of construction is also found at the Keeling House (Narvaez and Stoll, 70), which bears other similarities to the Lynnhaven House (see discussion in Section 8). The only remaining original lath in the house is found on the underside of the upper run of stairs; it is riven and held in place with wrought nails.

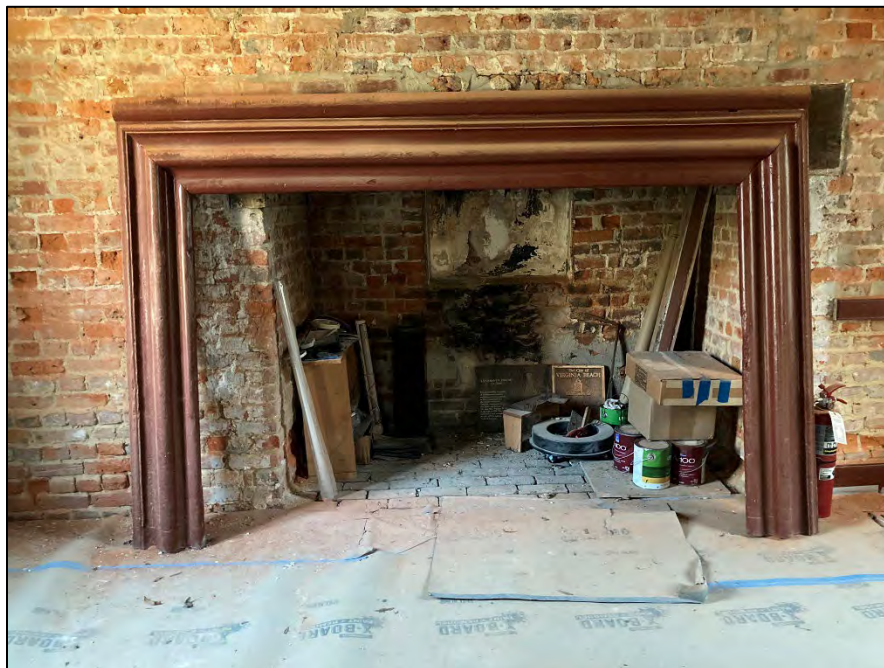
Hall, fireplace, December 2023.

The fireplace in the hall is original and was an important element of the 18th century space for its promise of hospitality, an increasingly important concept in the early 18th century. Although the original mantel has been missing for nearly 100 years (the 1934 HABS drawings note a “new” mantel in this space), the lintel is the original massive hewn beam, chamfered on the backside to facilitate smoke uptake, and the firebox has been restored to its original size: 6’11” wide by 3’6” deep by 4’7 ½” tall. It is slightly smaller than the firebox in the parlor, which is surprising, and supports the theories about shifting room use in the early 18th century. Current thinking suggests that the mantel currently leaning up against the hall fireplace was actually originally located in the parlor (Narvaez and Stoll, 60). Photos suggest that it was in the parlor when APVA acquired the house and the HABS drawings document it in that room as well. The mantel is an early 18th century design with mitered sidepieces molded with a complex bolection profile, while the horizontal member has a pulvinated molding.

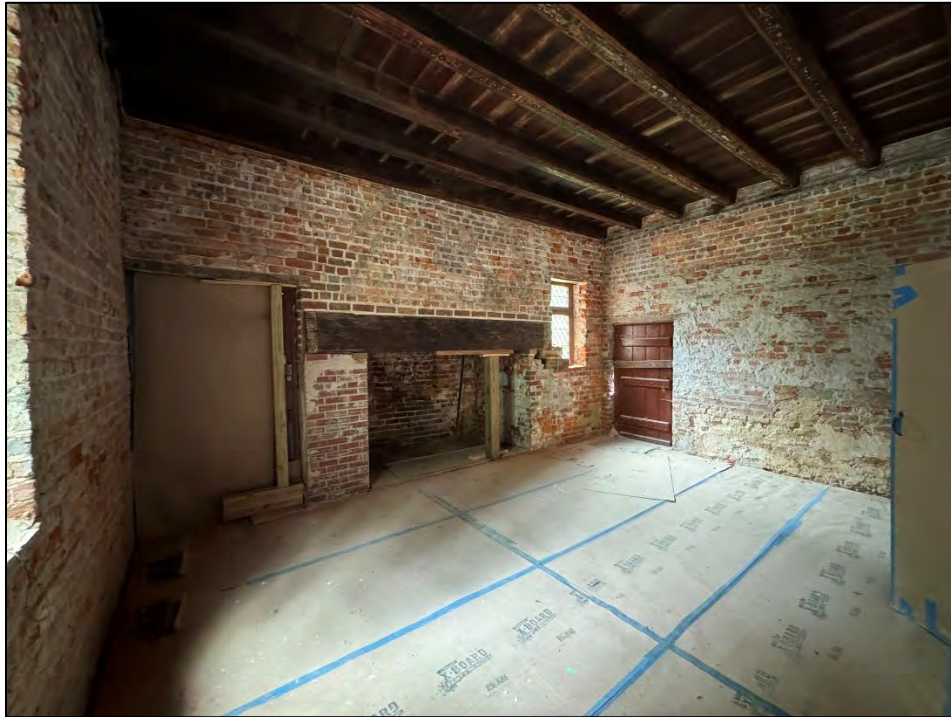
Parlor/dining room, May 2024. The doorway that originally led outside, to the north yard, is on the left beside the fireplace, while the doorway that originally connected to the rear chamber is in the center of the photo.

The parlor/dining room is a slightly smaller room than the hall with two exterior doors, one on the rear (east) elevation and one on the north end beside the fireplace. The rear door opening, which is original with a hewn lintel set in the surrounding brickwork, would have initially been an interior door that opened into the rear chamber in the now-missing rear wing. The north door opening, also original with a hewn lintel set in bed molding, was an original exterior door, suggesting that the service yard, and possibly a detached kitchen, was located to the north of the main house.

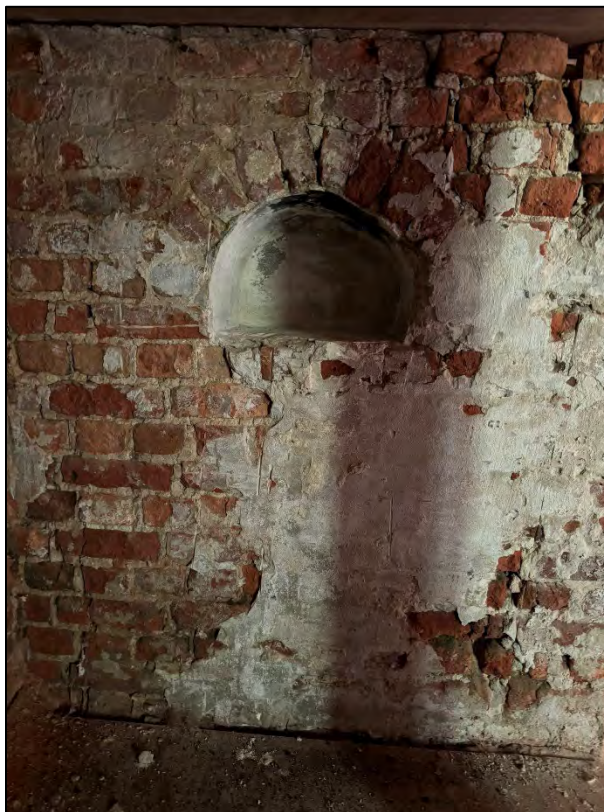
Parlor/dining room fireplace, warming niche on the east wall of the firebox. May 2024.

The fireplace in the parlor/dining room was originally larger than the one found in the hall, though it had been reduced in size by the time APVA acquired the property. The masonry of this fireplace required more reconstruction than the one in the hall, but it has been restored to close to its original size. During the removal of filler bricks, APVA discovered warming niches on both side walls of the firebox; the one on the west wall had to be completely reconstructed but the one on the east wall appears to be original. The large hewn lintel over the fireplace had to be replaced in recent years due to severe termite damage, but the front face of the original beam was removed and affixed to the new structural beam so that the appearance is unchanged.

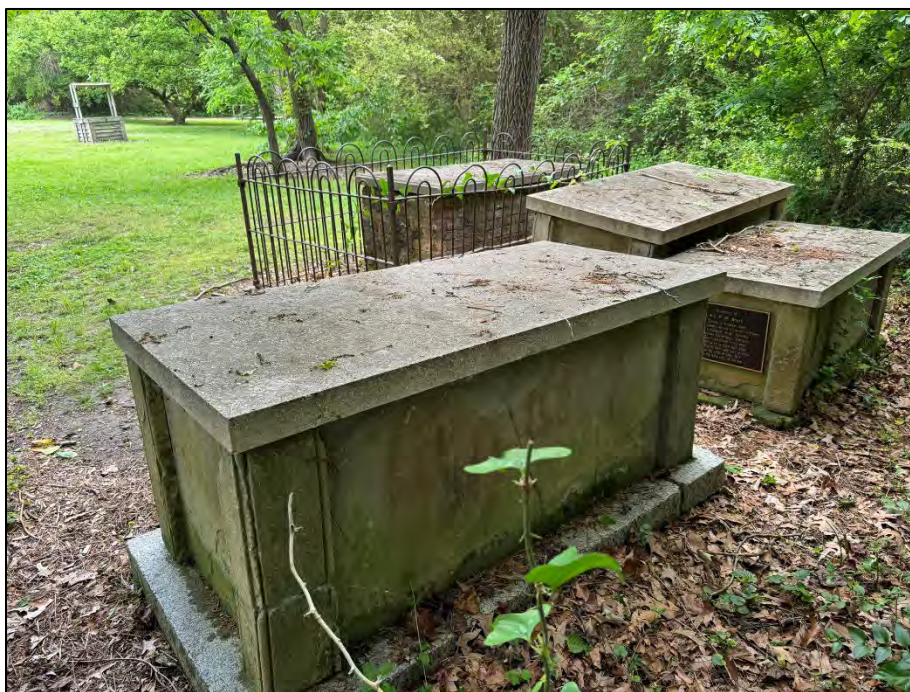
Cemetery, looking northeast. Lynnhaven House is just out of frame to the left. May 2024.

type of enclosure around the cemetery; instead, it consists of four marked graves located very close together in a cluster, all oriented east-west. The overgrown vegetation in the surrounding trees is threatening, but the City keeps the cemetery mowed. There are four box tombs, three have sandstone walls and one is brick construction. All have replacement cast stone slabs taking the place of the very deteriorated original ledger stones, except for the brick tomb belonging to Eliza Walke which retains its original ledger stone. Interred here are William Boush (1759-1834), Mary Boush, his wife (1764-1822), William F.M. Boush, their son, (1793(?)–1818), and Eliza J.S. Walke (1802(?)–1884), daughter of William and Mary Boush.

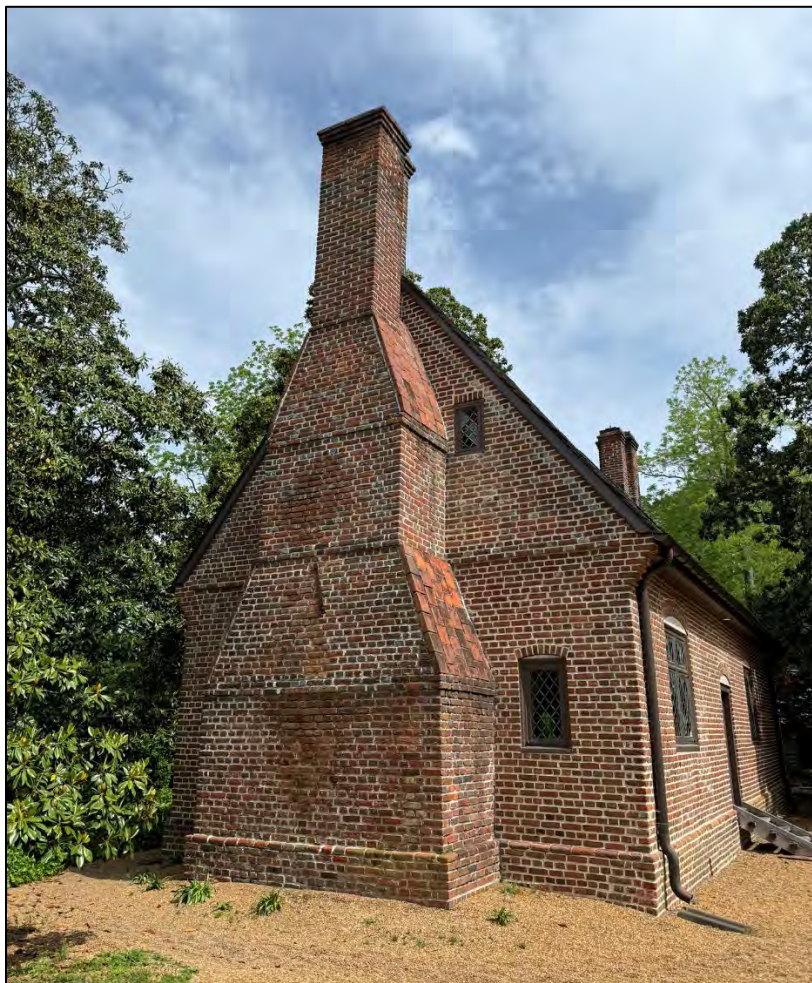
Thoroughgood House, Virginia Beach, Virginia, May 2024. Compare the chimney, the brick corbels at the corners, and the glazed headers following the rake with Lynnhaven.
