CONDITION SURVEY OF THE SLAVE QUARTER
BUILDING AT WALNUT VALLEY (090-
0023/44SY0262), SURRY COUNTY, VIRGINIA

Condition Survey of the Slave Quarter Building at Walnut Valley (090- 0023/44SY0262), Surry County, Virginia

WMCAR Project No. 12-26

MARCH 7, 2013

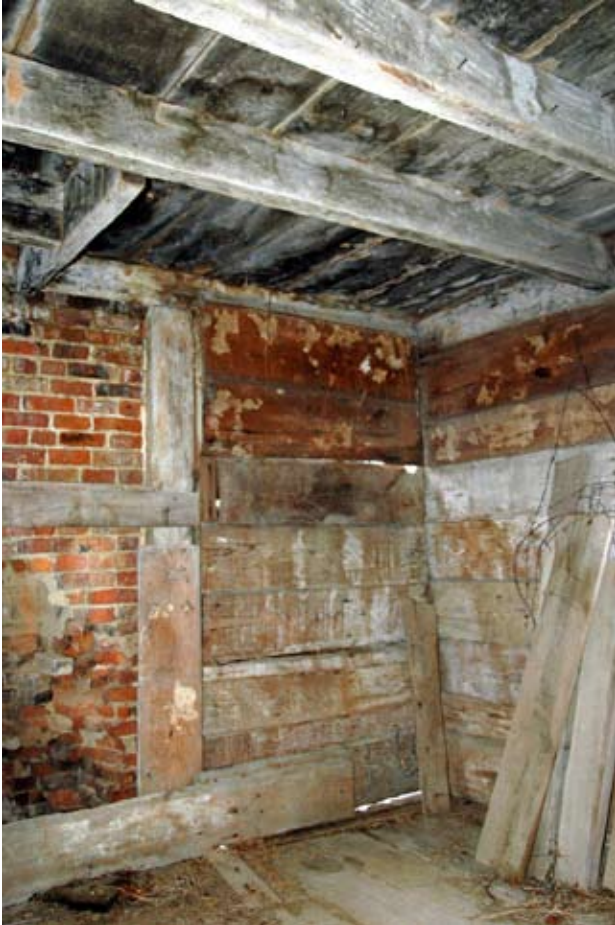
Figure 2. Closed stair opening.

(Figures 2 and 3). Evidence for the original partition between the rooms appears as a series of mortises in the floor.

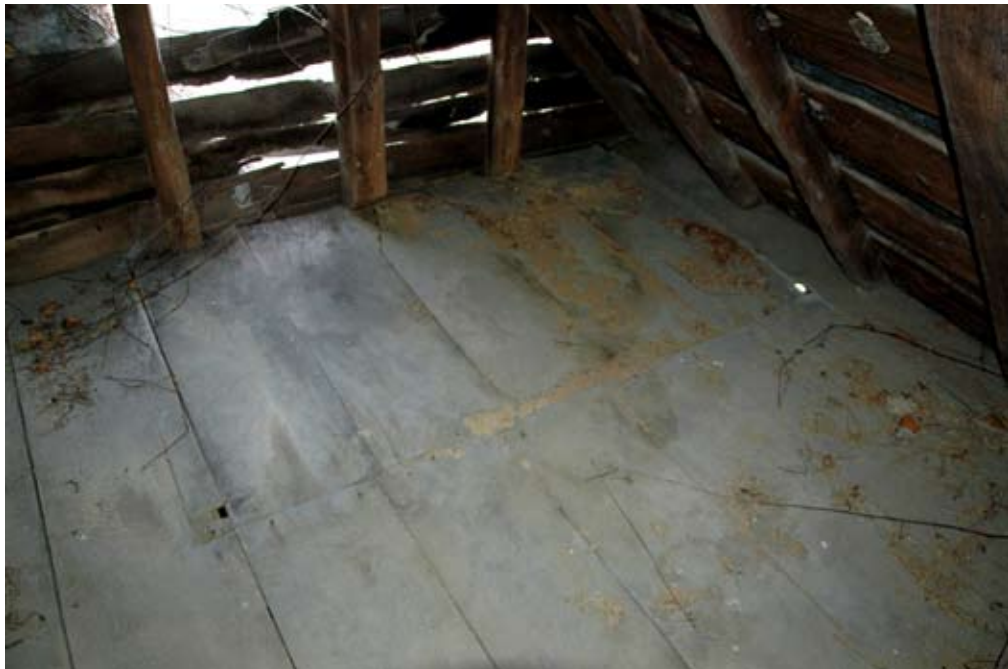
Figure 3. Closed stair opening and newel mortise.

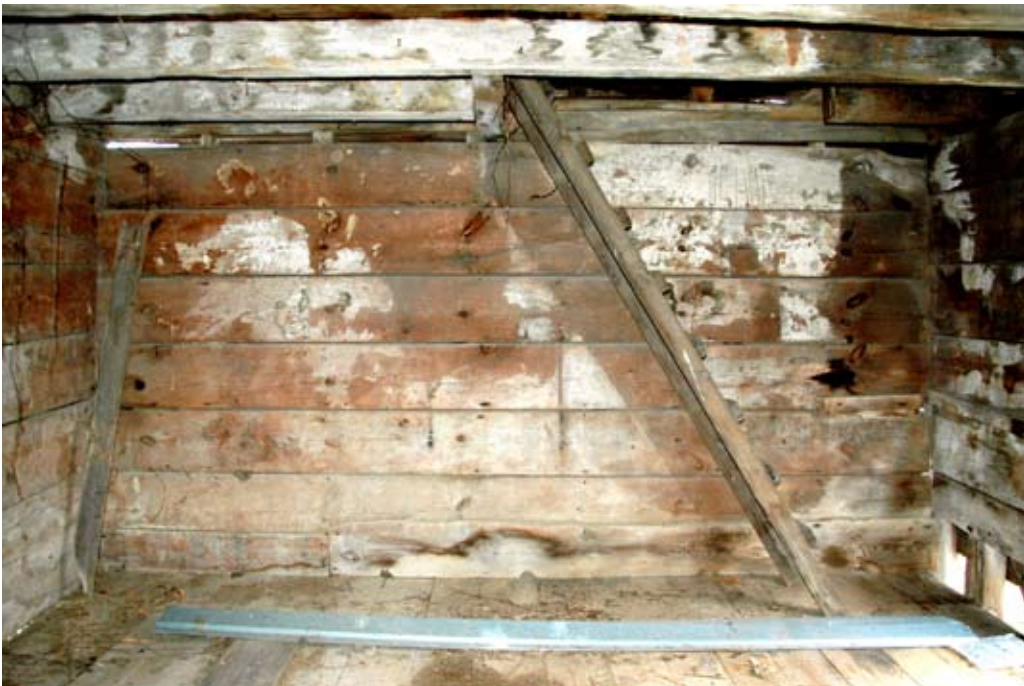
Sometime in the middle or late decades of the nineteenth century, the ground-floor room was finished with cyphered pine sheathing applied with late cut nails, and the stair moved to the west wall (Figure 4). (Lap joints for the stringers of this second stair are visible in the header of the present opening). Upstairs, the attic partition moved to its present location to cordon off the new stair space. This alteration expanded the adjacent living space and so improved the domestic accommodations of the upper floor. These new arrangements may have corresponded with the building's occupation by free tenant farmers.

Figure 4. Nineteenth-century sheathing with ghost of Period II stair.
