Virginia Department of Historic Resources PIF Resource Information Sheet

General Property Information	For Staff Use Only DHR ID #: 023-0016
Property Name(s): <u>Presque Isle</u>	
Property Date(s): <u>1815</u> <input checked="" type="checkbox"/> Circa <input type="checkbox"/> Pre <input type="checkbox"/> Post Open to Public? <input type="checkbox"/> Yes <input checked="" type="checkbox"/> Limited <input type="checkbox"/> No	
Property Address: <u>8183 Fox Groves Road</u> City: <u>Remington</u> Zip: <u>22734</u>	
County or Ind. City: <u>Culpeper County</u> USGS Quad(s): <u>Remington, Brandy Station</u>

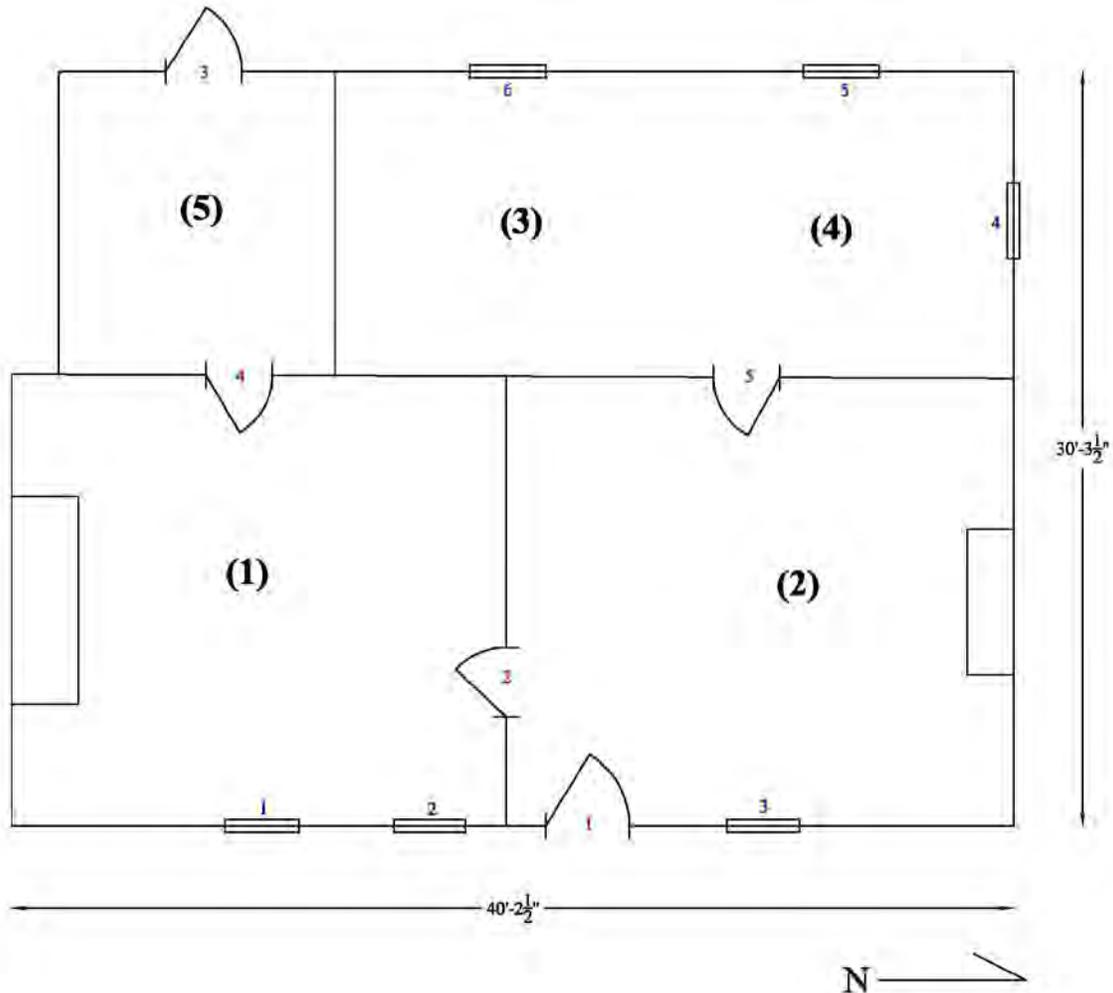
Principal Construction Type: Masonry (Brick) **One Story** **Footprint:**

Number of Rooms: 5 (2 original – Phase I; 3 in rear additions – not measured)

Dimensions: (1) 16 ft. 11 in. (E-W) x 18 ft. 11.5 in. (N-S); 8 ft. 1.5 in. (H)

The structure is situated perpendicular to the main house across the gravel road. Modern additions to the rear of the structure are of cinderblock and frame/screen construction, with the same standing seam metal roof found on the original portion. The floor of Room 2 (north) apparently has been raised 6.5 in. above the floor level in Room 1 (south). Room 2 has narrow (2.5 in.) floor boards attached with wire nails; Room 1 has 5-in.-wide floor boards fastened with machine-cut nails. The ceilings in both rooms are modern replacements, with thin grooved boards held with wire nails.

Note closers at every 4th course at SE corner. Front (east) façade windows with headers of 12 soldier bricks with 5 stretchers above (which are 1/4 brick stepped out). Closet added to west side of chimney in Room 2, with modern dimensional lumber and sheet rock. In Room 2, note presence of nailers, two on east wall near door at chair rail height; and two to east and west of chimney at 5 ft. from floor (see similar evidence in second building to north).
