# National Register of Historic Places Registration Form

Historic name: Mount Vernon High School

Other names/site number: Original Mount Vernon High School

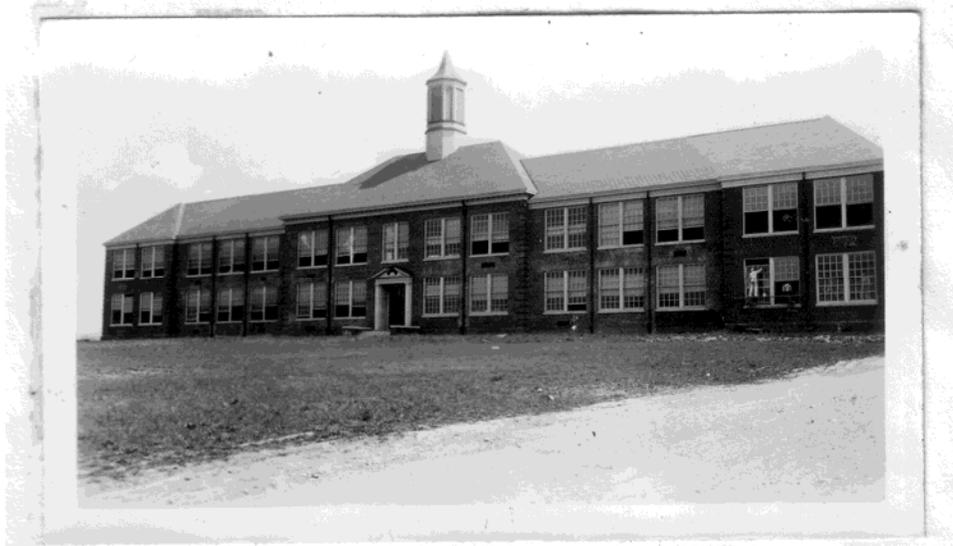
Figure 1. View of the north facade of the main building as viewed from northeast shown in the 1942 Surveyor Yearbook.

The original building is a two-story U-shaped Colonial Revival building constructed in 1939. The original section of the school is 235 foot-long rectangular multi-wythe brick building with two-stretcher brick Flemish bond, brick quoins, and grapevine tooled mortar joints. The original main building was initially constructed to house twelve classrooms, various administrative offices, and a mechanical space. The main entry is centered at the north façade, includes a double door with a twelve-lite transom surrounded by a decorative broken wood pediment with fluted pilasters and dentil details. The front façade is further defined with fifteen bays of large paired twelve-over-twelve double hung wood windows punctuating the facade. The building also features: a concrete foundation; slate hipped roof; white octagonal wood cupola with dentil molding under a copper roof; and spire. The cupola is located at the center of the roof ridge in line with the main entry doors.

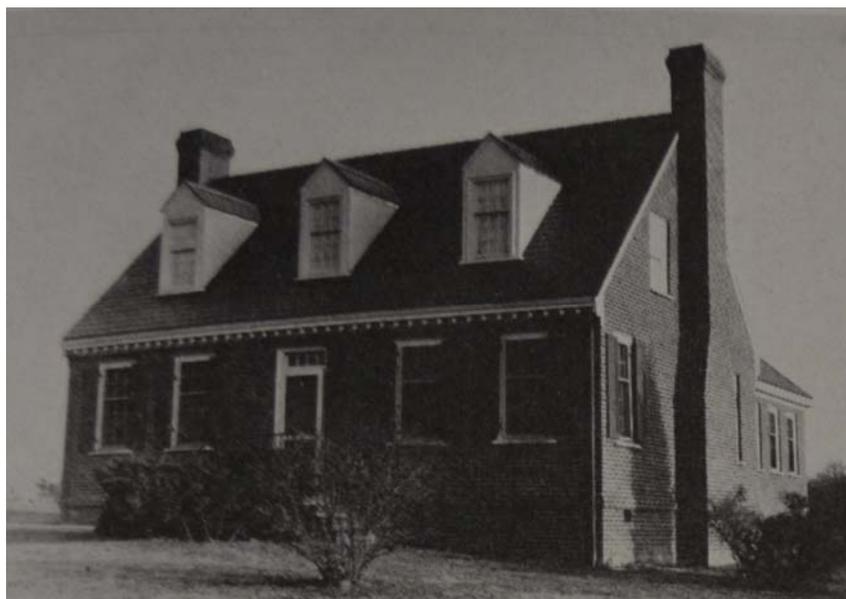
Figure 2. Historic photo from a 1943 yearbook of the original home economics building main facade, north, view from northeast.

The Home Economics Cottage was constructed in 1943 to the west of the main building. Designed with a Colonial Revival influence, the Home Economics Cottage was one of the first additions to the campus as part of the original PWA funding request. The original building was T-shaped with the main entry centered on the 3-bay wide north façade. The building is approximately 42 feet long extending southward.

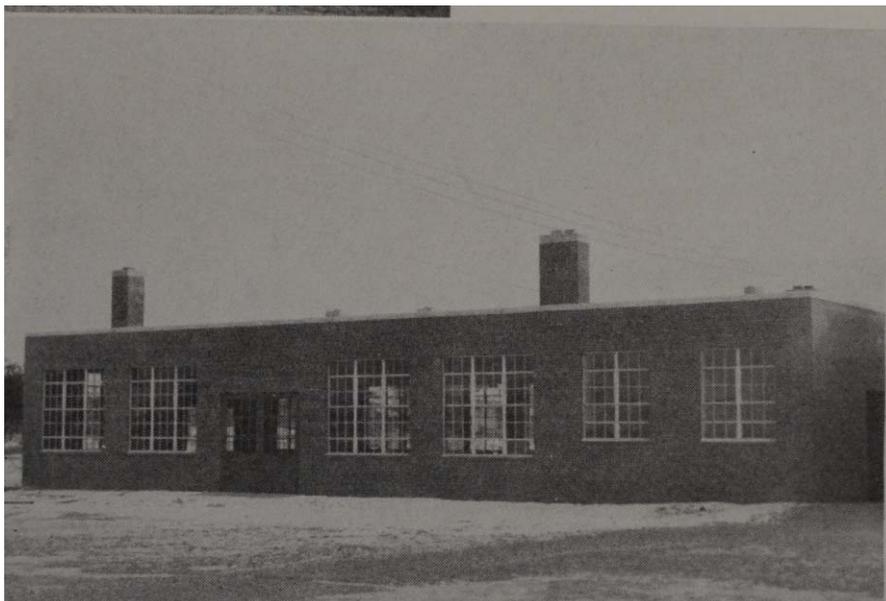
Figure 3. Historic photo of the “old” shop from a 1943 yearbook showing the principal facade and one set of garage doors, view from northeast.

The “Old” Shop, is a contributing building located at the southeast end of the site, just north of the athletic fields. The building is a rectangular one-story utilitarian Colonial Revival and Moderne brick structure added to the campus in 1944. Oriented east to west, the building is approximately 60 feet wide by 90 feet long and constructed of multi-wythe brick in 2-stretcher brick Flemish bond with tan mortar tooled with a concave finish.
