Virginia Department of Historic Resources PIF Resource Information Sheet

General Property Information	For Staff Use Only DHR ID #: 041-0089
Property Name(s): <u>Riverside</u>	
Property Date(s): <u>Possibly late 18th century; early 19th century</u> X Circa <input type="checkbox"/> Pre <input type="checkbox"/> Post Open to Public? <input type="checkbox"/> Yes <input type="checkbox"/> Limited X No	
Property Address: <u>11161 River Road</u> City: <u>Sutherlin</u> Zip: <u>24594</u>	
County or Ind. City: <u>Halifax County</u> USGS Quad(s): <u>Oak Level, VA</u>

Riverside

041-0089

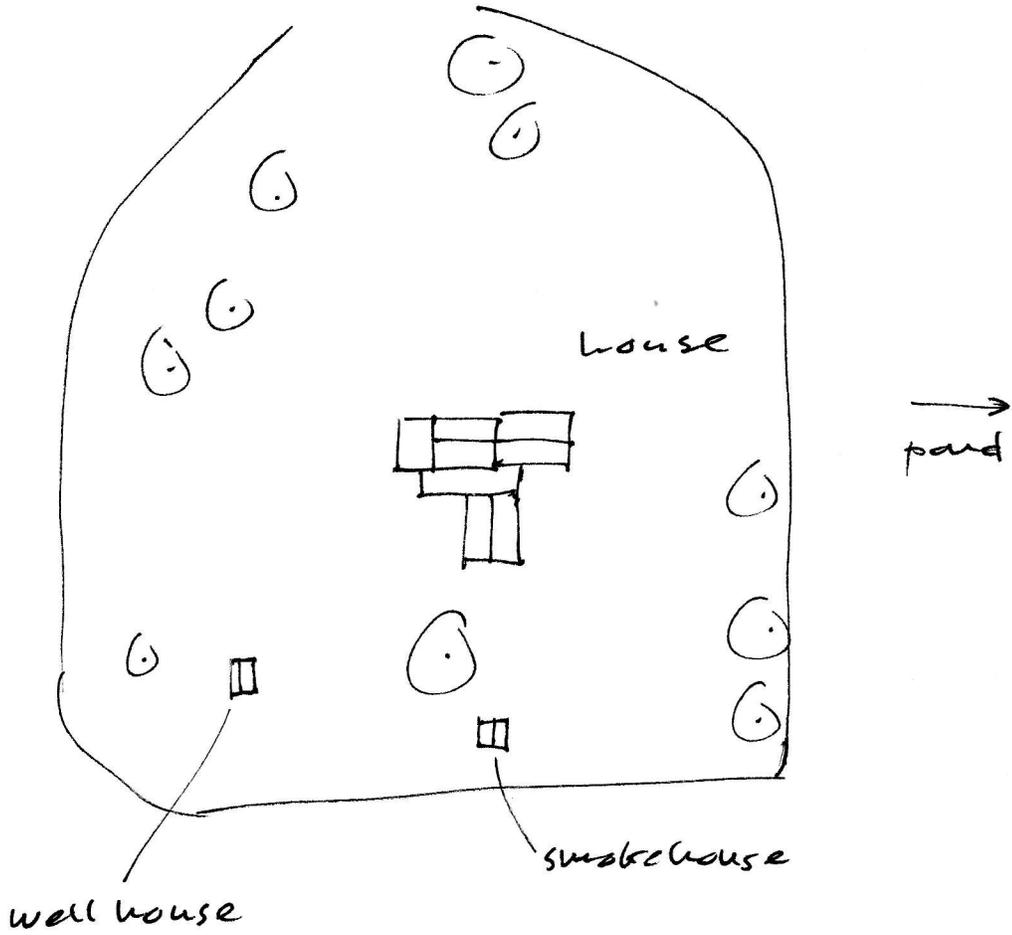
Architectural Description of Individual Resource: *(Please describe architectural patterns, types, features, additions, remodelings, or other alterations. A sketch of the current floor plan would be appreciated.)*

Riverside, located at 11161 River Road near the Dan River in southeast Halifax County, Virginia, is a rambling one and two-story frame house with multiple phases of construction. The story-with-garret core section is believed to date to the eighteenth century and features beaded weatherboard siding and a brick chimney on the west end. The core section and the rest of the house now face north, toward the road and away from the river, but the core may originally have faced south toward the river. A two-story addition with a brick chimney was made to the east end of the core in the early nineteenth century, possibly in 1813, and a one-story shed wing was added to the west end at an undetermined date or period. Finally, perhaps about 1840, a two-story section with a brick chimney was added to the rear, connected to the rest of the house by a one-story hyphen. The final arrangement resembles the front house/back house form, although in this instance the front section is earlier. Other exterior features include a front porch on turned and classical posts and pilasters, and windows in a variety of pane patterns, including nine-over-nine.
